General Summary

R & R Home Inspections

61774 Alta loma Dr
Joshua Tree CA 92252

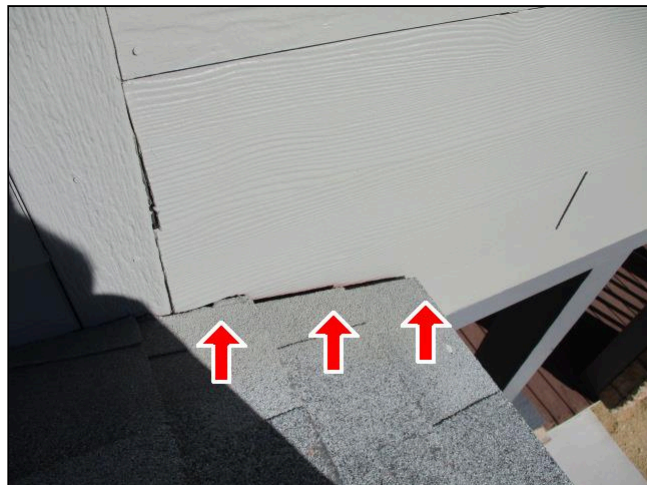
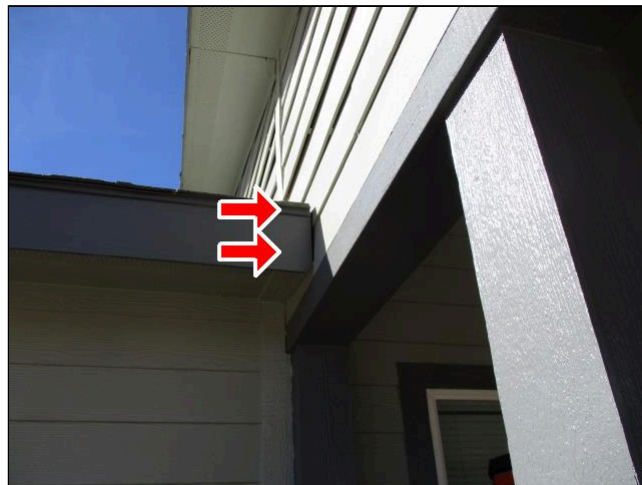
The home had no kick-out flashing installed where walls extended past roof edges. Kick-out flashing is designed and installed to divert water from behind the exterior wall covering at areas of the home where a sidewall extends out past a connecting roof eave. This condition may allow moisture intrusion of the exterior wall covering. Moisture intrusion of the wall structure can damage home materials and encourage the growth of mold. Long term moisture intrusion can cause structural damage from wood decay. The Inspector recommends that before the expiration of your Inspection Objection Deadline, you consult with a qualified roofing contractor to discuss options and costs for kickout

flashing installation.

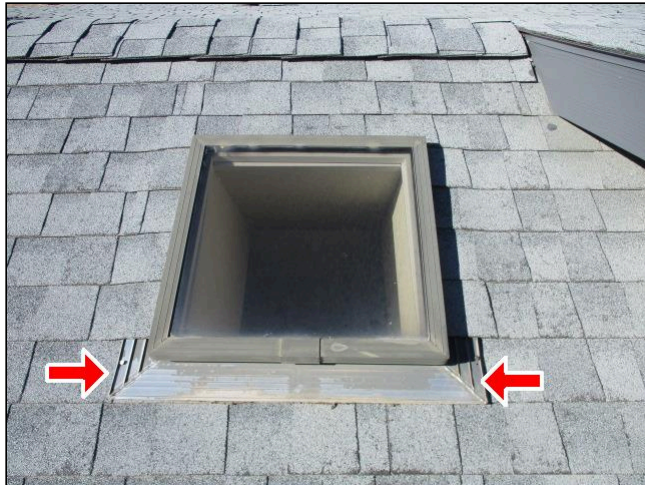
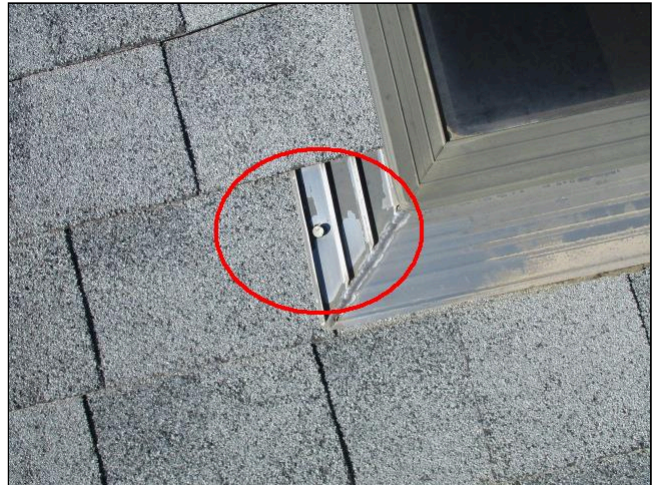
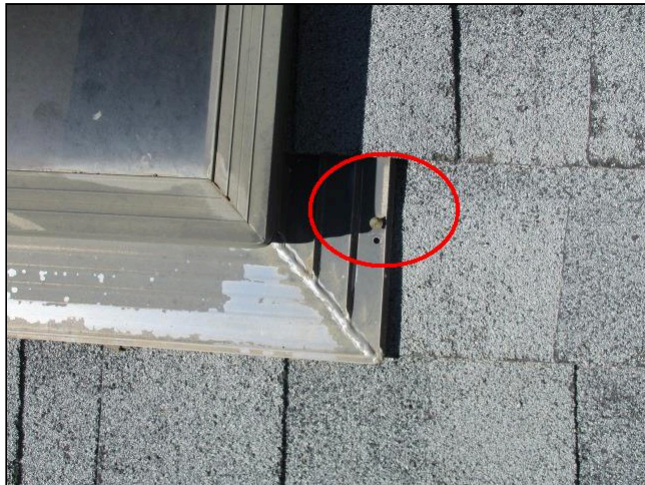
Exposed fasteners were observed at the skylight . The Inspector recommends an evaluation and any necessary work be performed by a qualified roofing contractor.

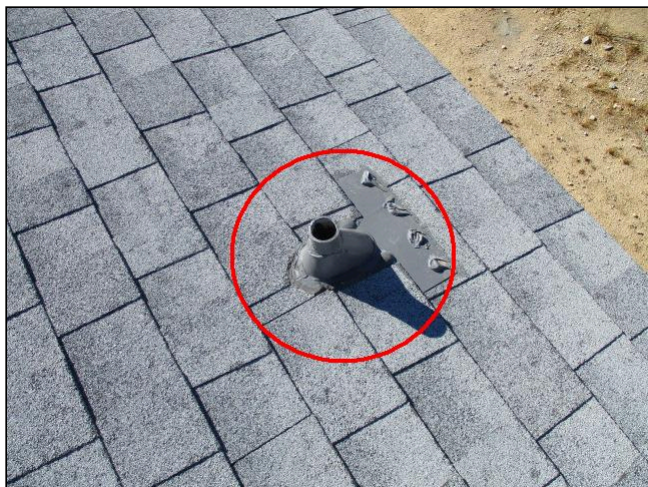
1.3 Item 1(Picture) left side (facing front)

A plumbing vent pipe serving the drain, waste and vent system had inadequate clearance above the roof. To help ensure that they perform according to their design, plumbing vent pipes should terminate a minimum of 6 inches above the roof or above the level of anticipated snow accumulation. The Inspector recommends correction by a qualified plumbing contractor.

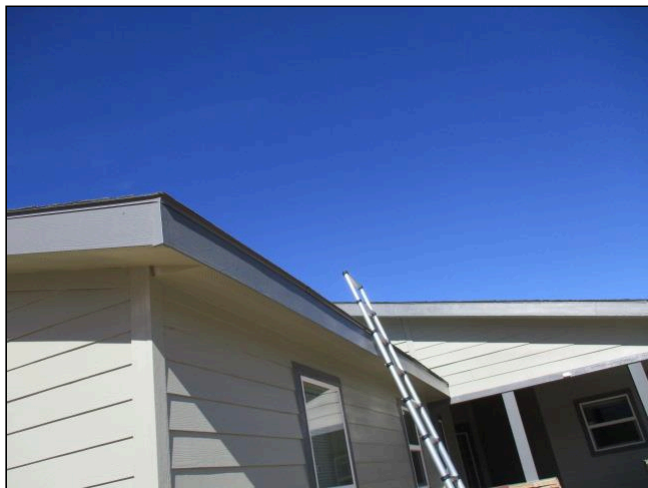
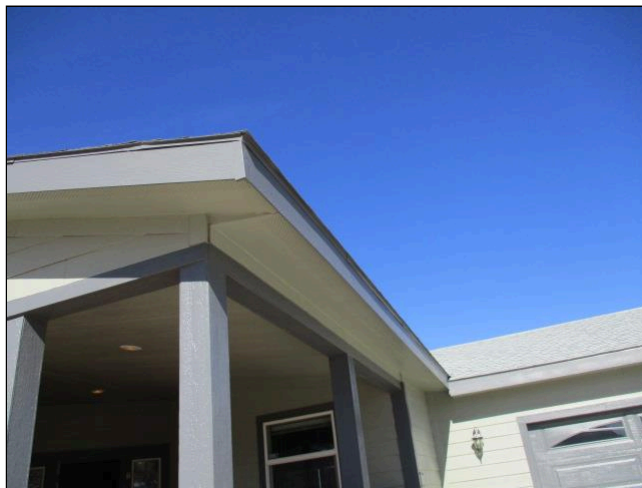
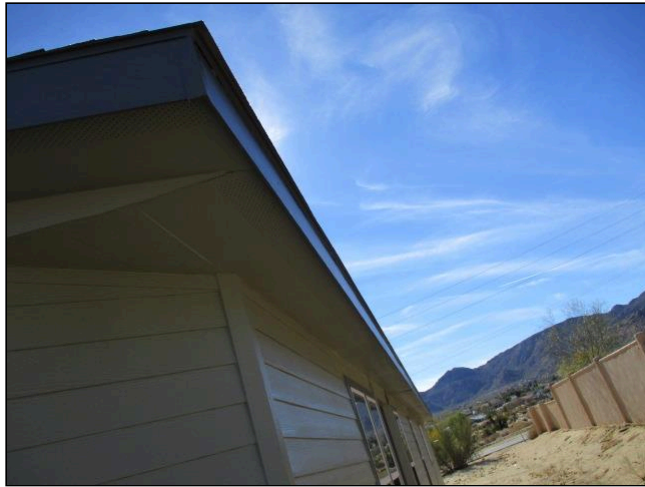
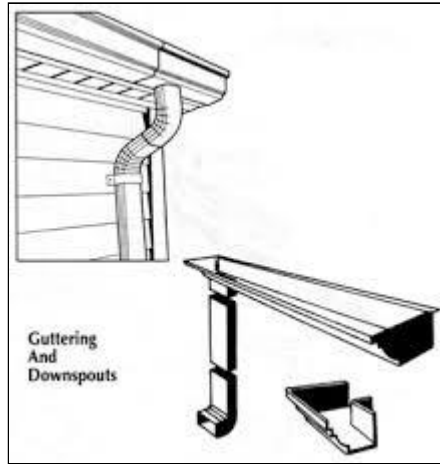
The home had no roof drainage system to channel roof drainage away from the foundation. The Inspector recommends installation of a roof drainage system to help protect the home structure and occupants.

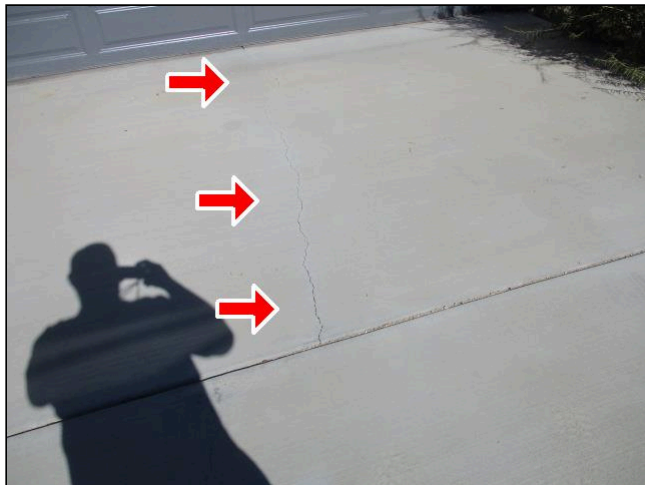
Common cracks ($\frac{1}{4}$ -inch or less) were visible in the driveway at the time of the inspection. Cracks exceeding $\frac{1}{4}$ inch should be filled with an appropriate sealant to avoid continued damage to the driveway surface from freezing moisture.

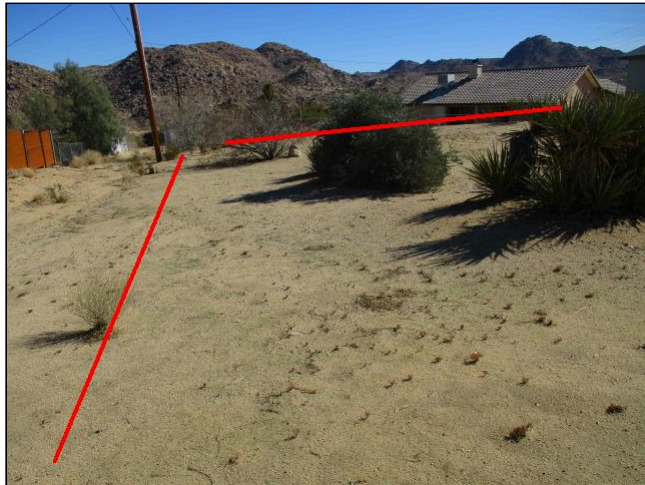
3.2 Item 1(Picture)

No fence was installed on the north and east side of the property.

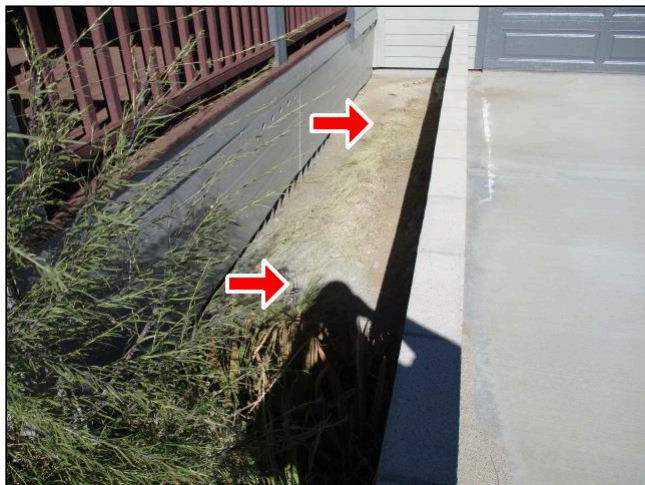
3.3 Item 1(Picture)

Marginal site drainage was observed next to the deck structure. Proper drainage is needed to help prevent water from standing and/or ponding next to the crawl space and foundation.

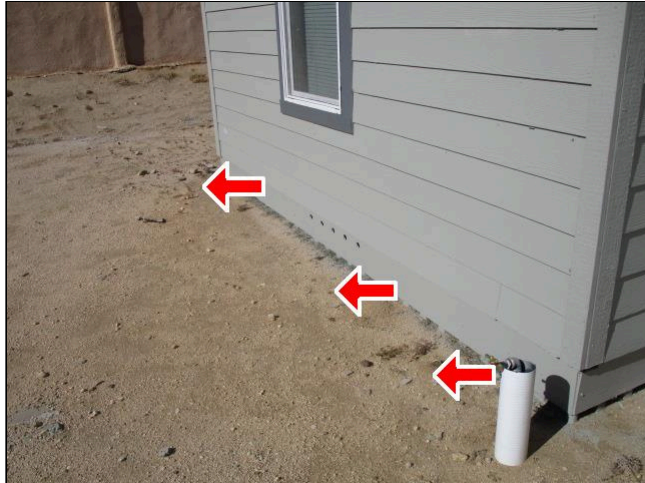
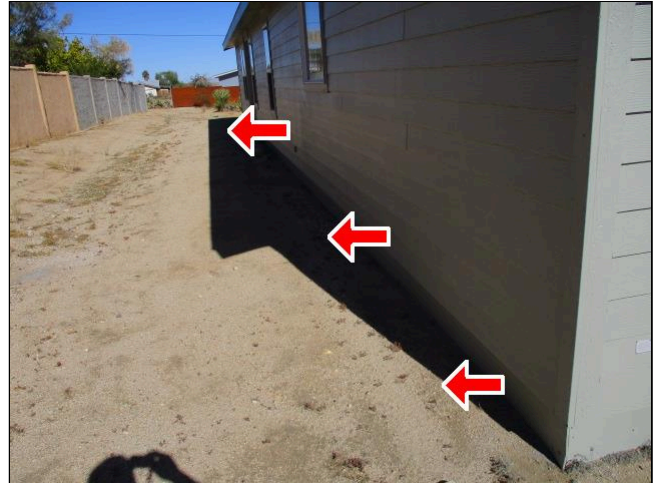
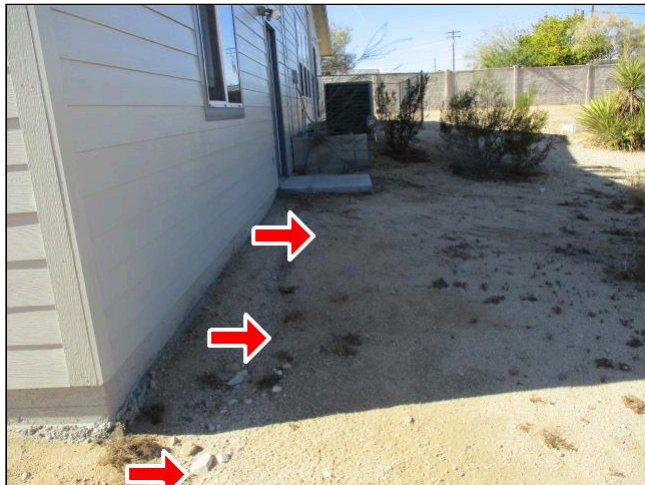
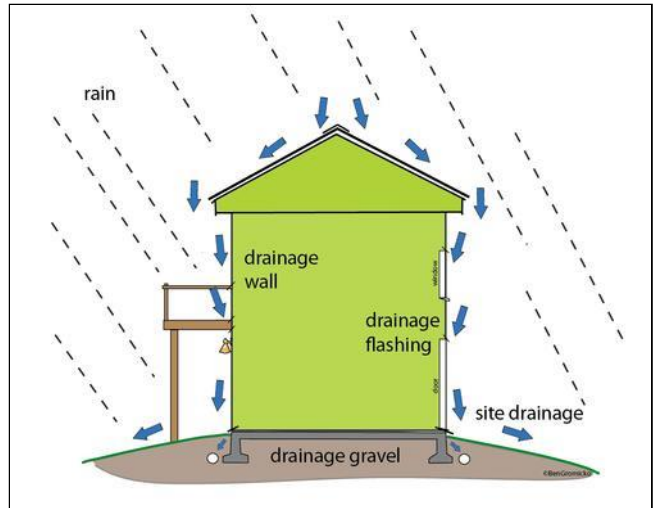
Swales at the side of the home were noted as being too shallow and can allow for water to flow out towards the foundation of the home during heavy rain fall or snow accumulation. It is recommended that the swales be cut deeper to prevent water accumulation next to the foundation walls and allow for sufficient drainage.

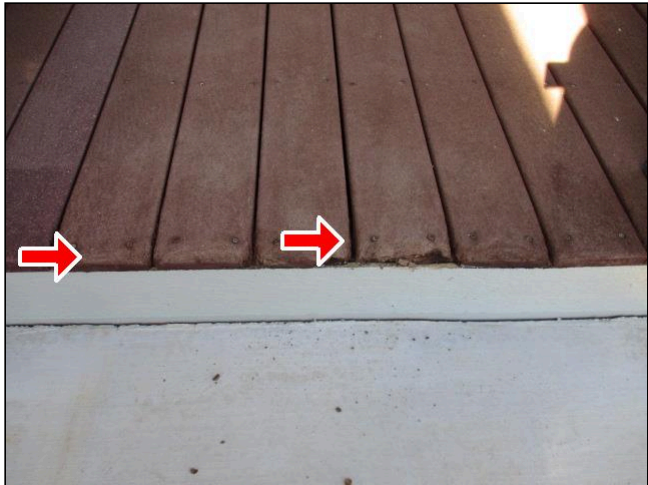
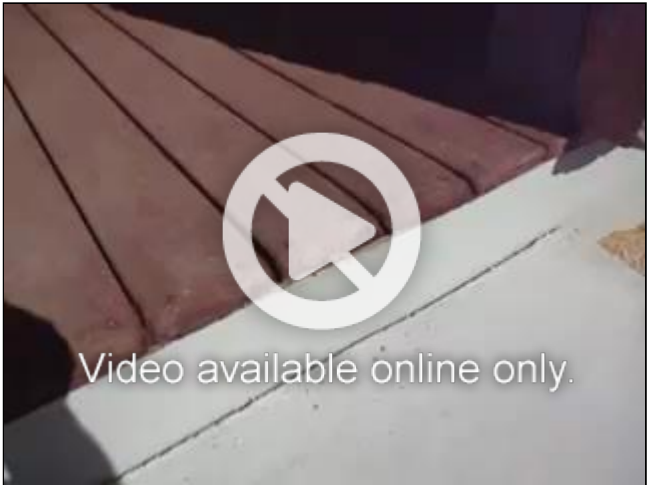
This deck exhibited moderate general deterioration at the time of the inspection.

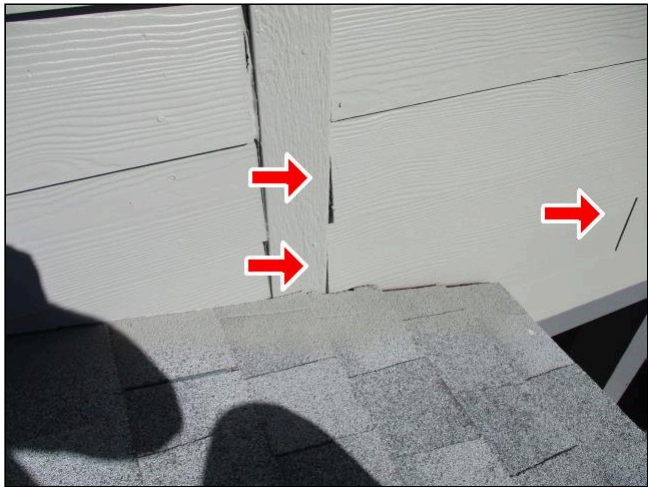
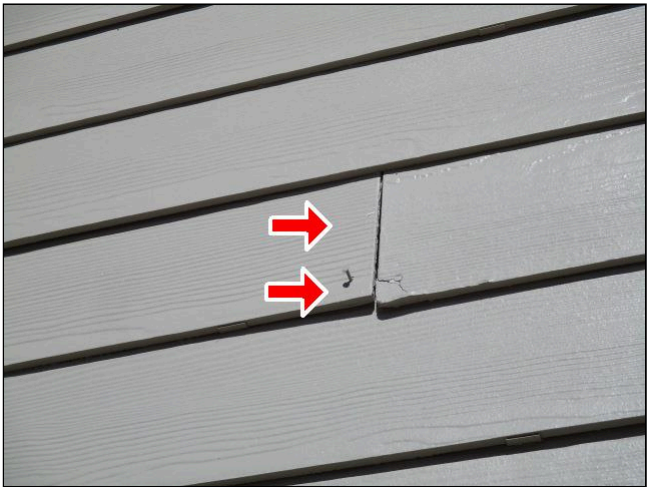
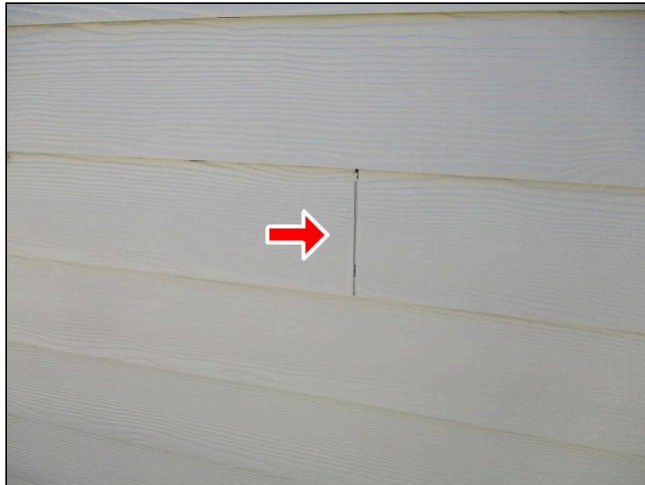
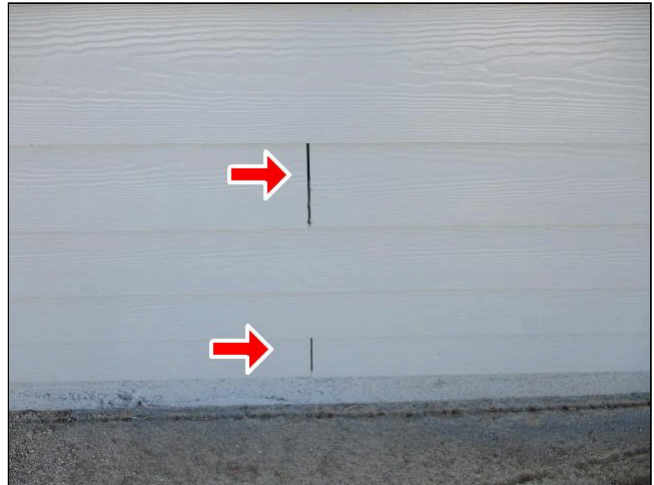
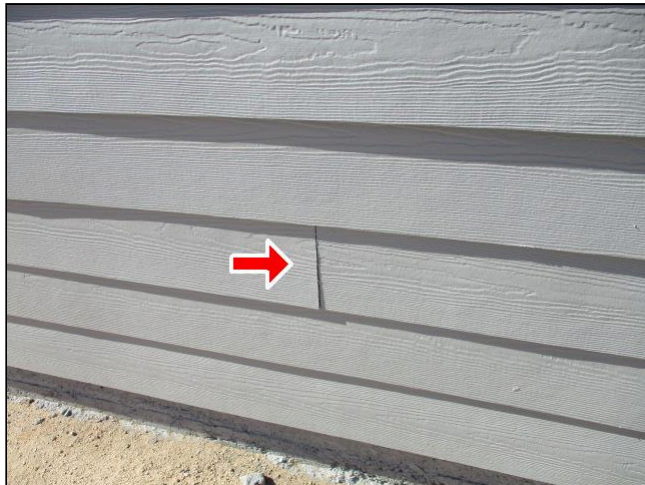
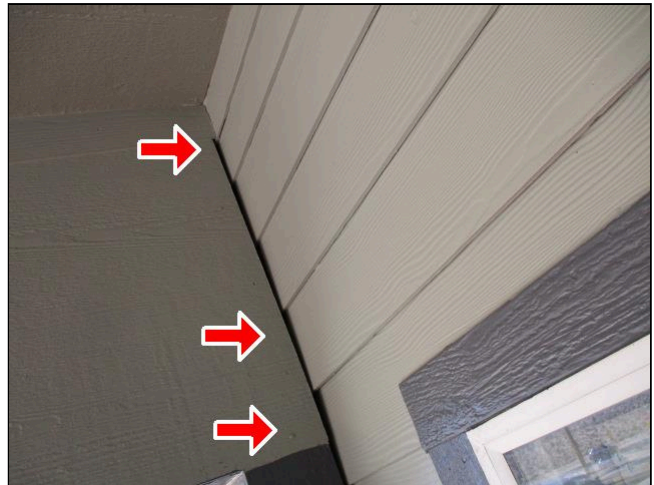
All joints between siding should be properly sealed. It is recommended to use elastomeric sealant.

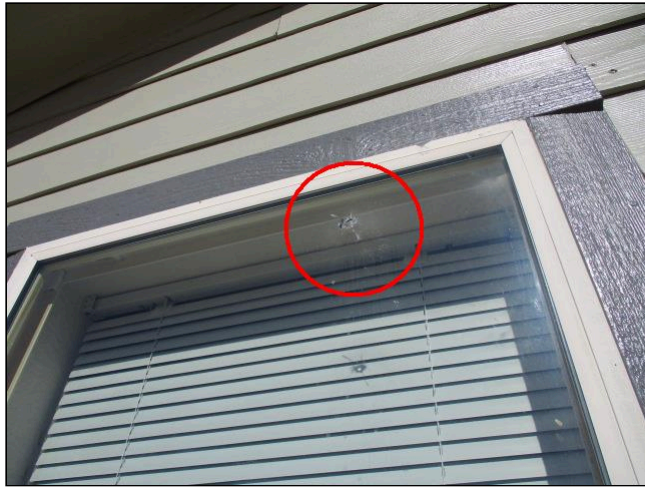
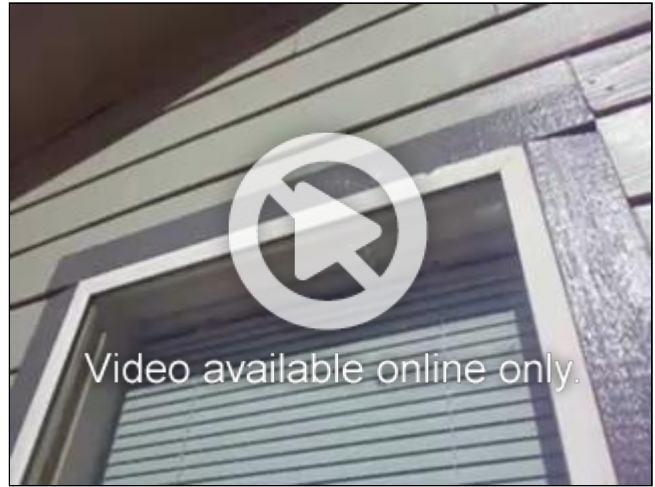
A window at the front of the house had a broken glass.

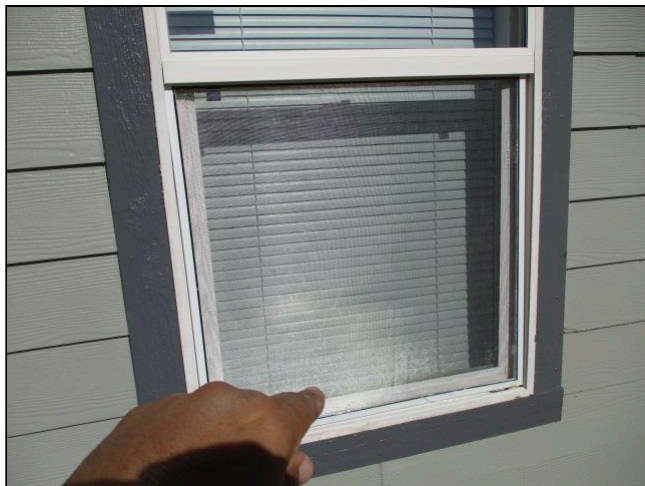
4.2 Item 3(Picture)
(3)

One or more of the window screens were observed to be damaged.

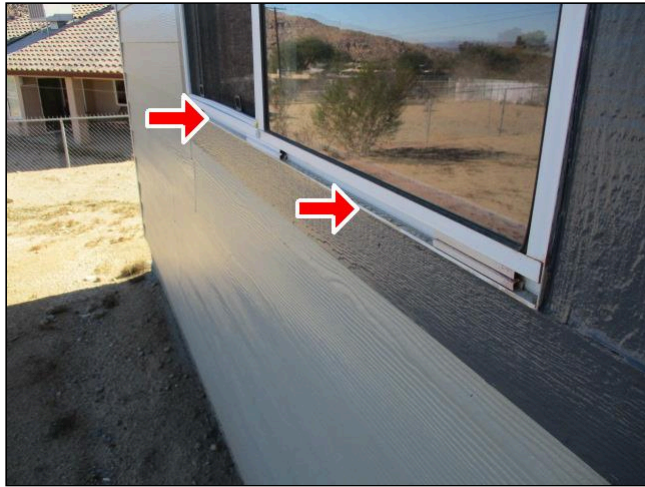
4.2 Item 4(Picture)

Window bottom rail damaged or missing. The Inspector recommends that before the expiration of your Inspection Objection Deadline you consult with a qualified contractor to discuss options and costs for correction.

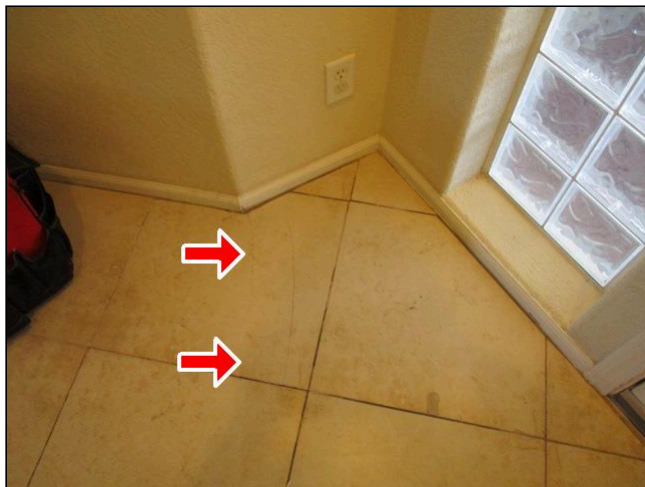
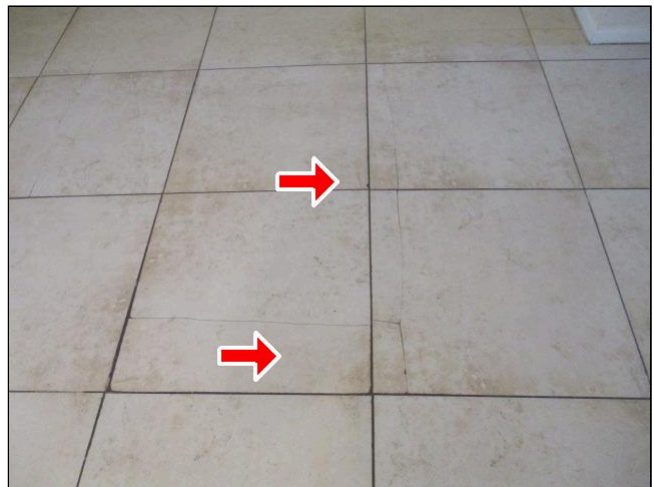
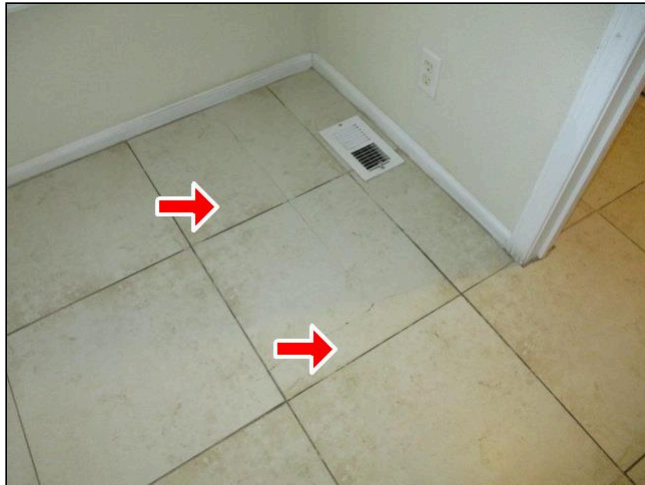
The living room had severe floor tile damage visible at the time of the inspection. You should consult with a qualified contractor to discuss options and costs for repair.

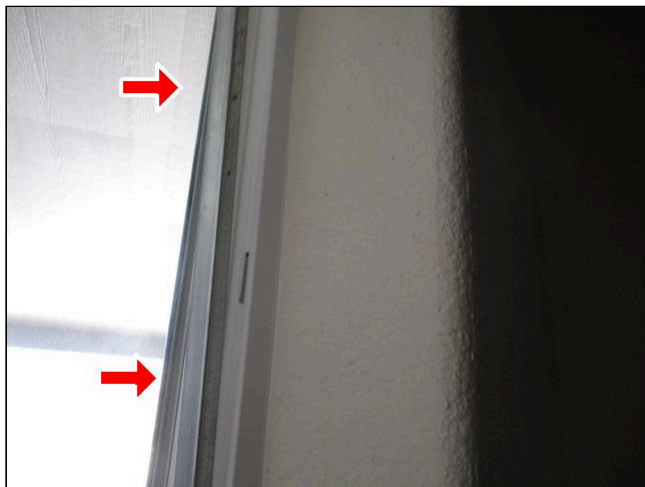
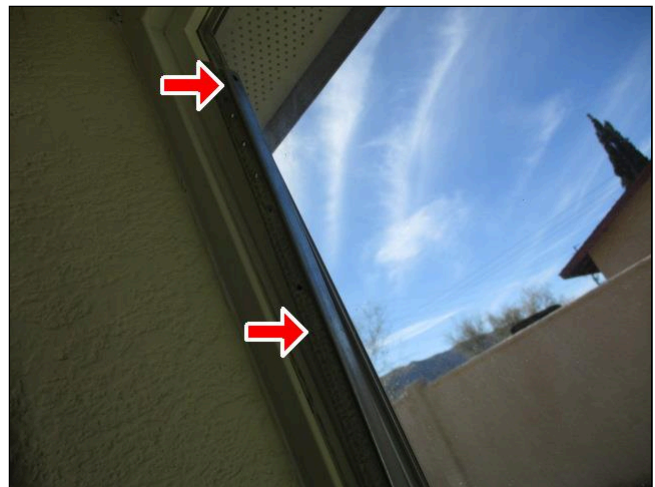
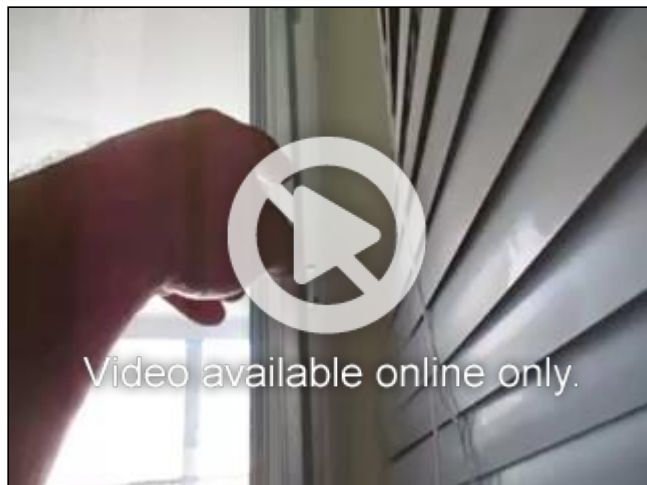
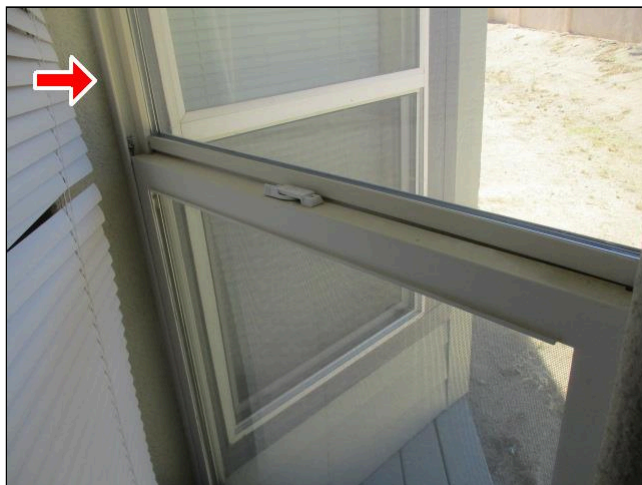
Few window in the interior are difficult to operate some are missing the window channel balance. Repair or replacement is recommended.

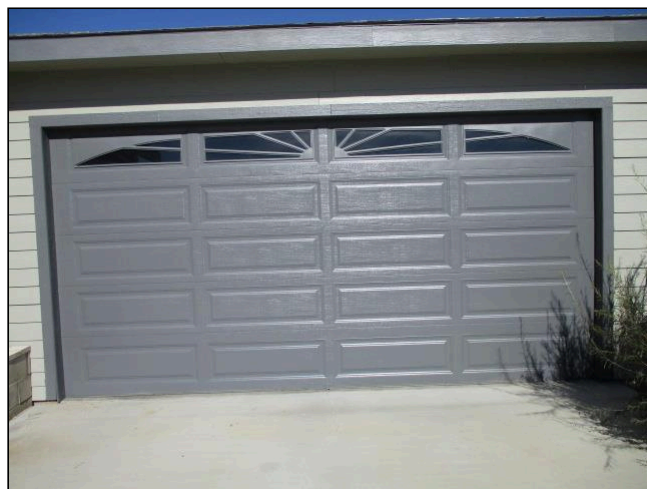
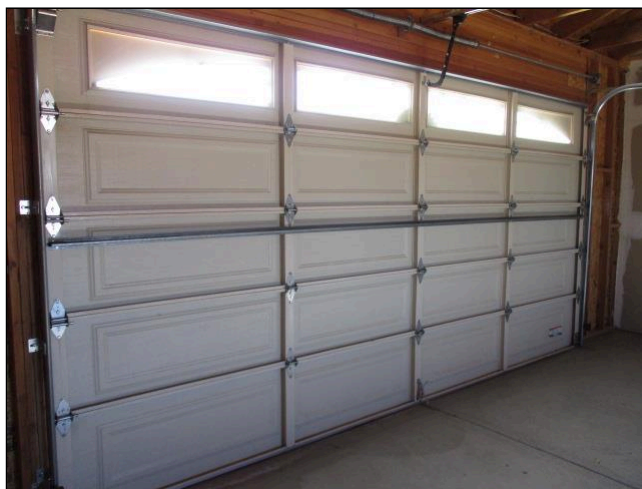
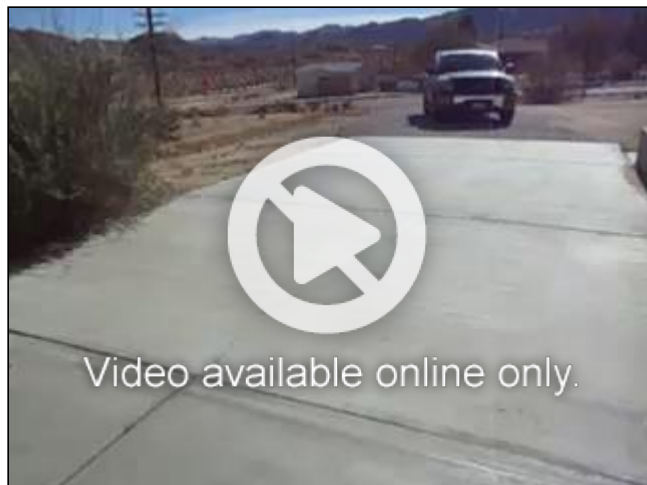
A garage vehicle door failed to reverse when a reasonable amount of resistance was applied. The Inspector recommends service by a qualified garage door contractor.

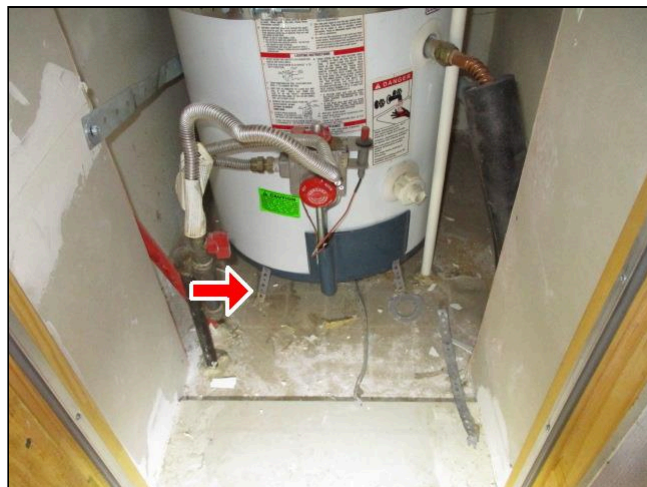
9.0 Item 1(Picture)

Drip pans are recommended below all hot water heaters, This will help contain leaks and prevent water damage.

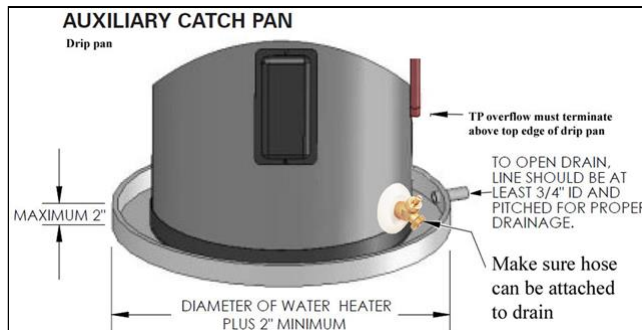
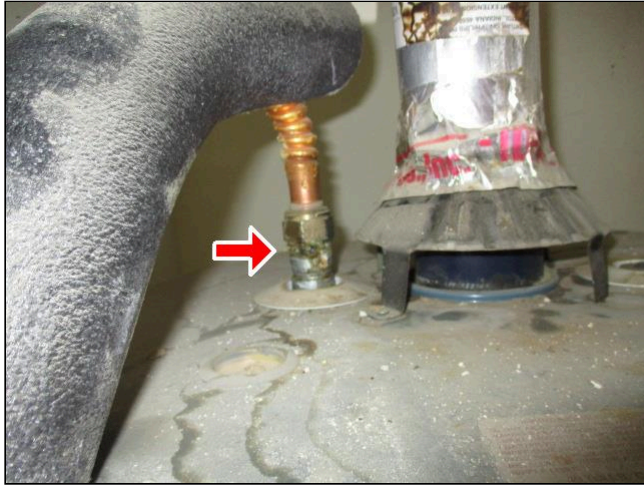
Corrosion visible on water pipes connected to this water heater appeared to be the result of dissimilar metals in contact with each other. This condition can cause galvanic

corrosion. The Inspector recommends installation of a dielectric union by a qualified plumbing contractor to help prevent further corrosion, deterioration and/or leakage made possible by this condition.

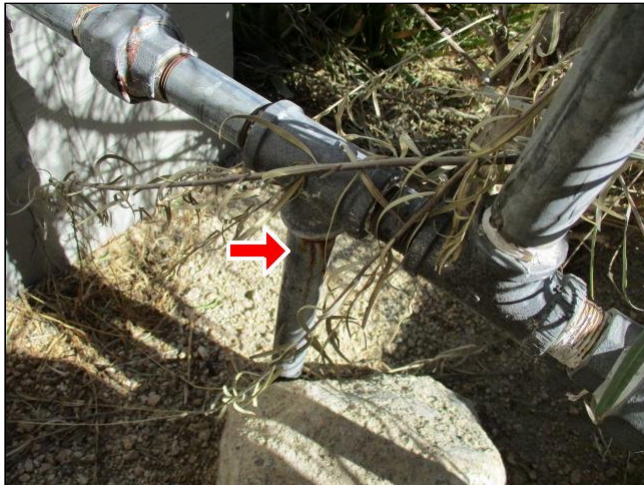
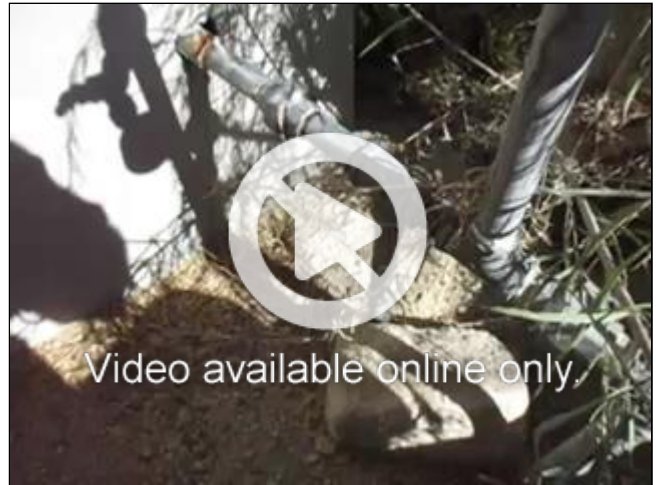
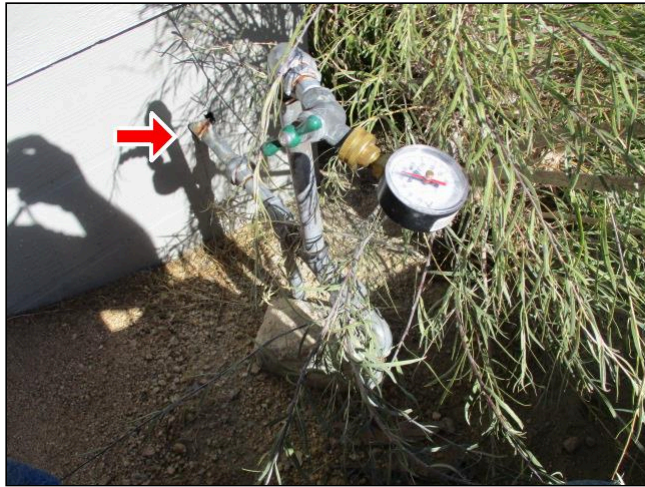
Corroded supply pipes . The Inspector recommends replacement by a qualified contractor to prevent future damage.

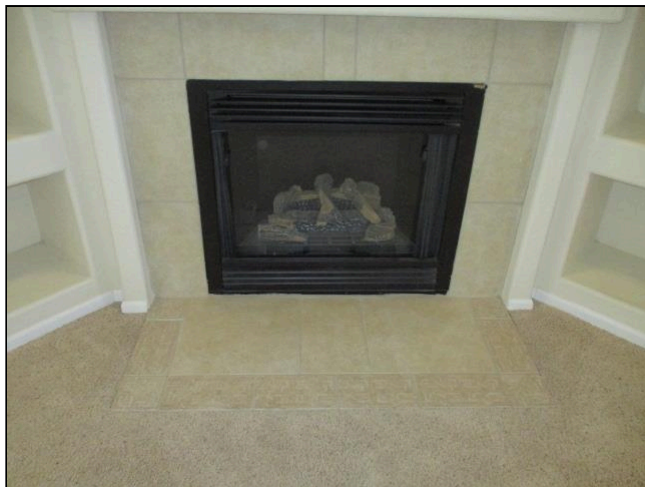
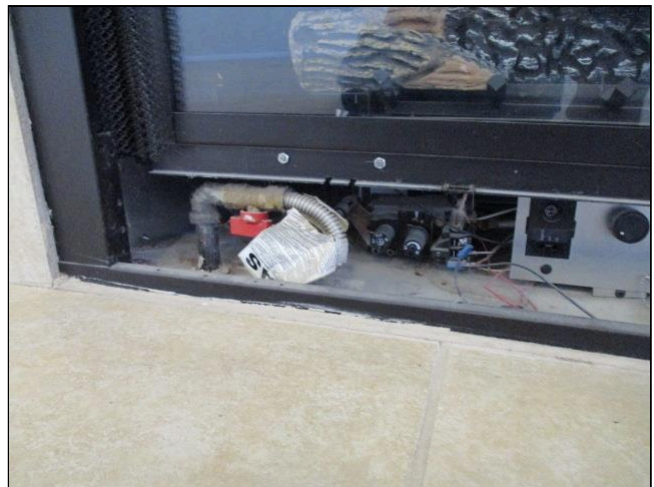
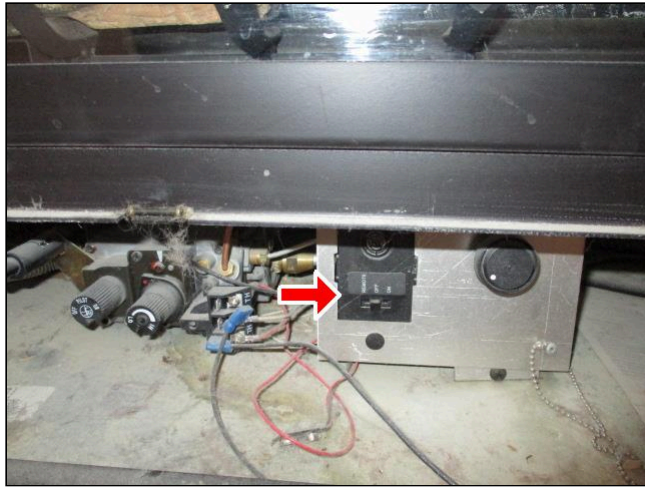
The fireplace in the living room was turned off at the primary controls. Changing settings at the primary controls lies beyond the scope of the General Home Inspection. You should ask the seller to demonstrate the functionality of this fireplace or have it inspected by a specialist.

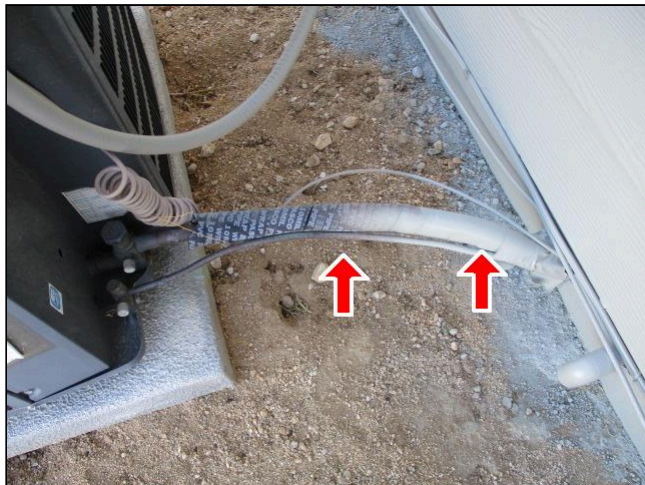
11.0 Item 11(Picture) rear of home

Damaged, deteriorated and/or missing insulation on the refrigerant lines should be repaired or replaced at the outside condenser

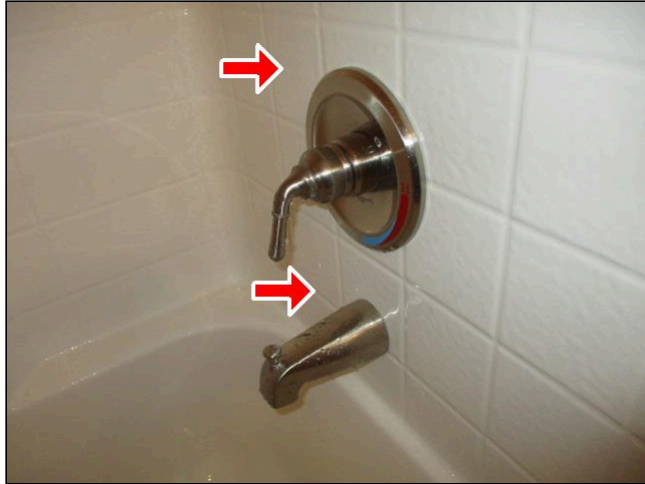
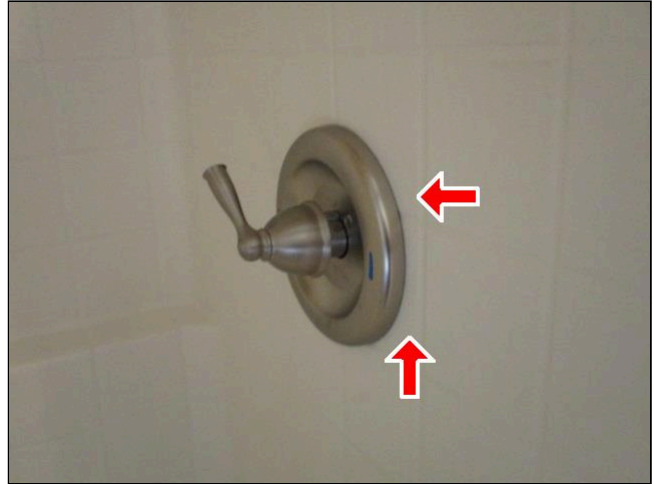
The shower handle and spout is not sealed at the wall. This condition has the potential to allow water to leak back into the wall cavity.

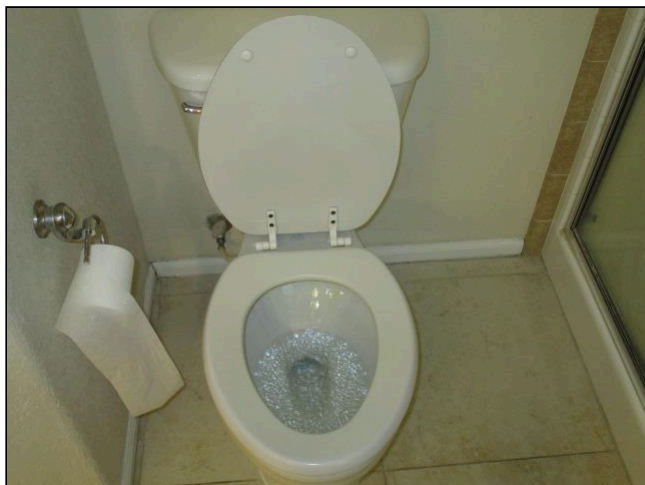
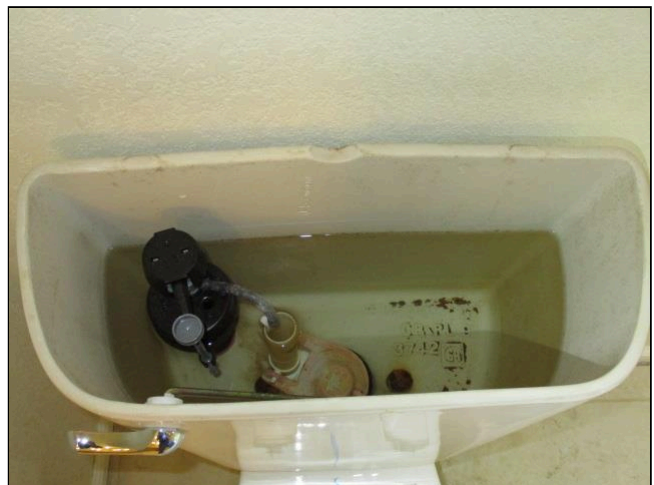
The toilet in the Master bathroom ran continuously at the time of the inspection. This usually indicates a failed flapper valve, the need for float mechanism adjustment or water leaking from the water tank into the bowl. Under some conditions, in homes with water supplied from a well, this condition can result in running the well dry and burning out the pump, requiring expensive repair. You should be diligent in maintaining toilet tank mechanisms in the future to avoid pump damage.

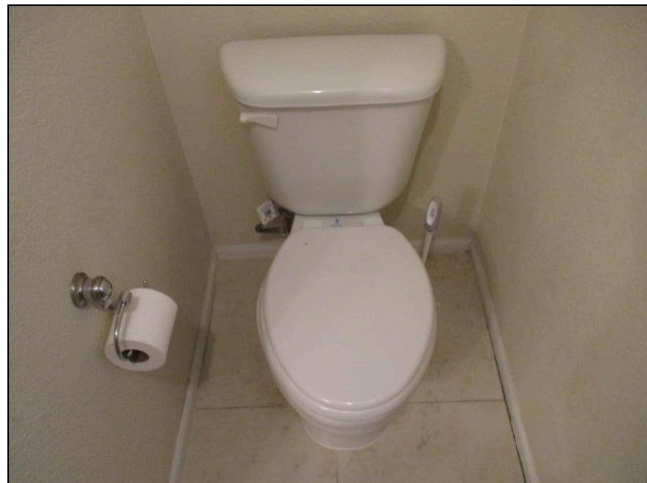
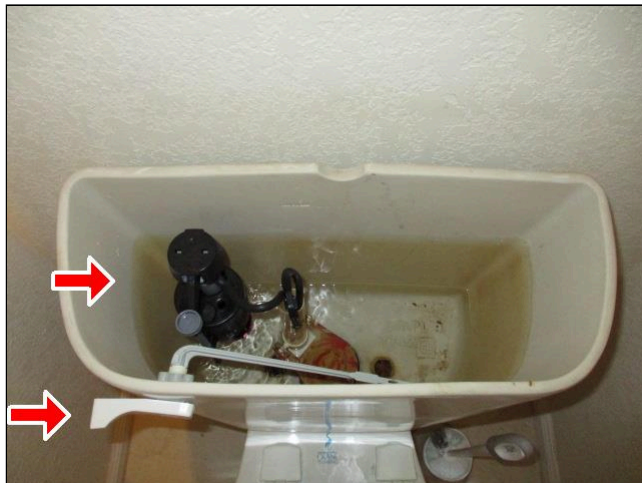
The master bathroom, the toilet handle did not return to position, indicating that components in the tank need adjustment or replacement.

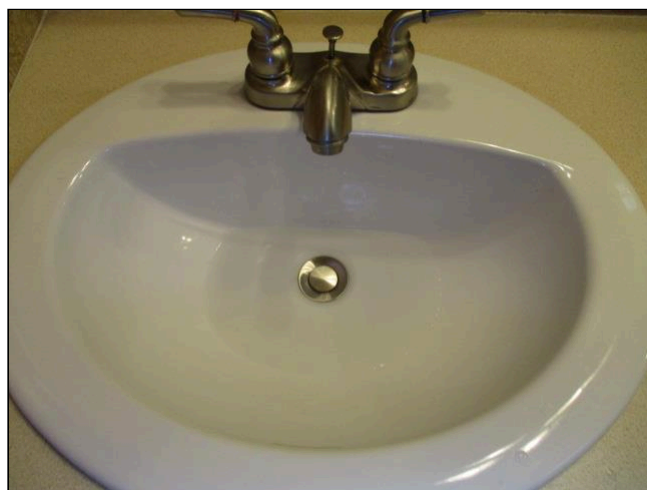
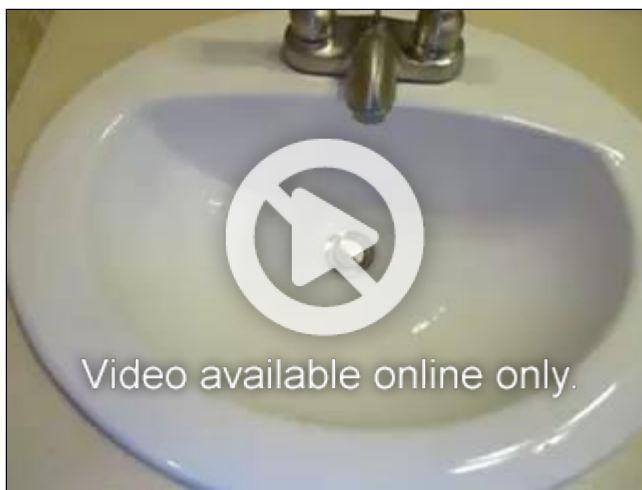
The sink in the hallway was slow to drain. The blockage should be located and cleared by a qualified plumbing contractor.

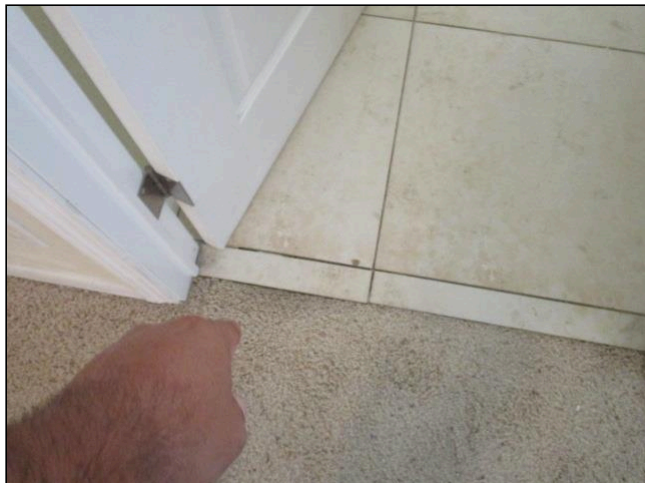
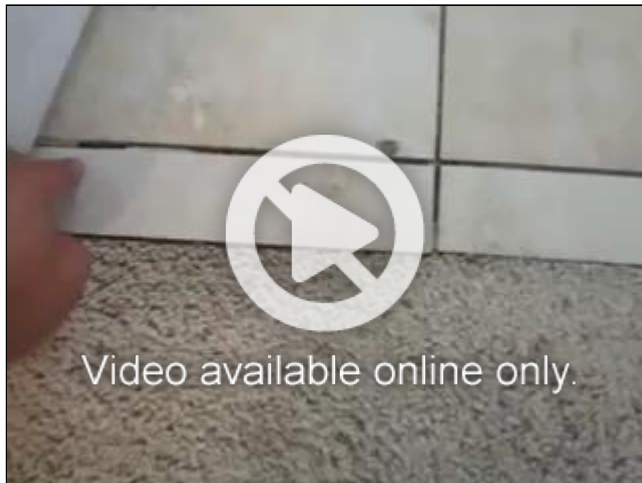
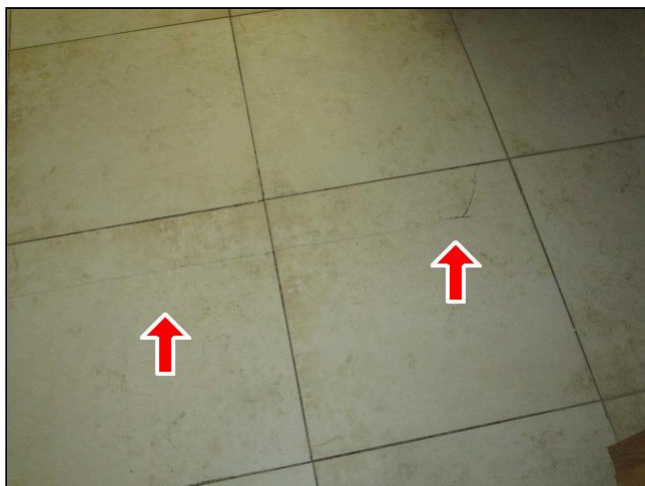
The master bathroom had severe floor tile damage visible at the time of the inspection. You should consult with a qualified contractor to discuss options and costs for repair.

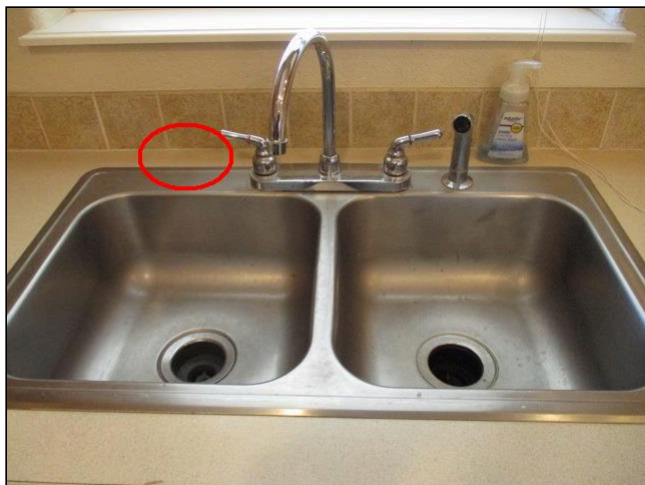
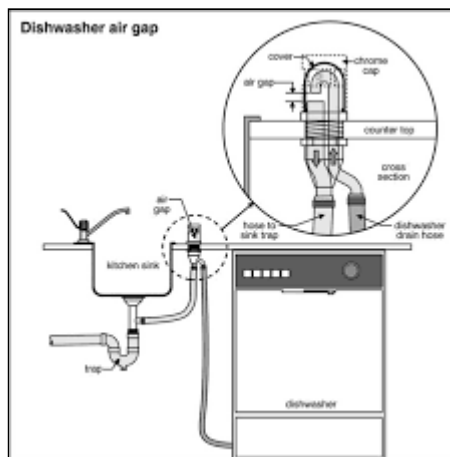
The dishwasher did not appear to have an anti-siphon device installed in the drain line. Anti-siphon devices are installed to prevent wastewater from the dishwasher from being siphoned back into the dishwasher and contaminating its contents. The Inspector recommends an anti-siphon device be installed by a qualified technician.

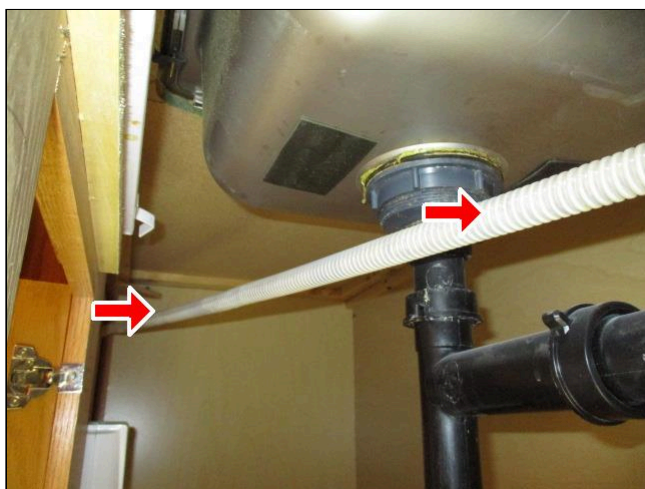
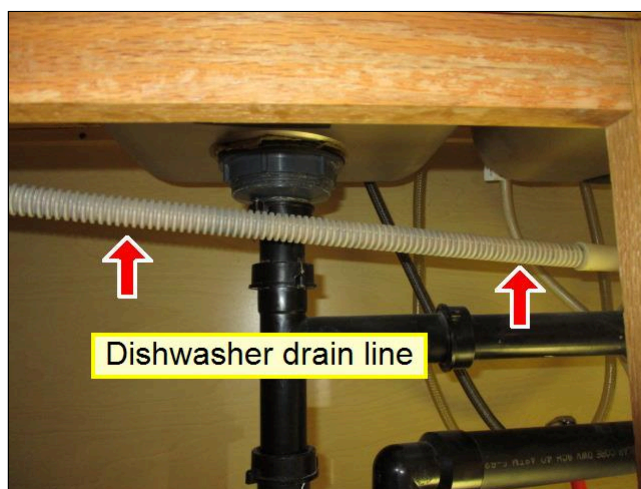
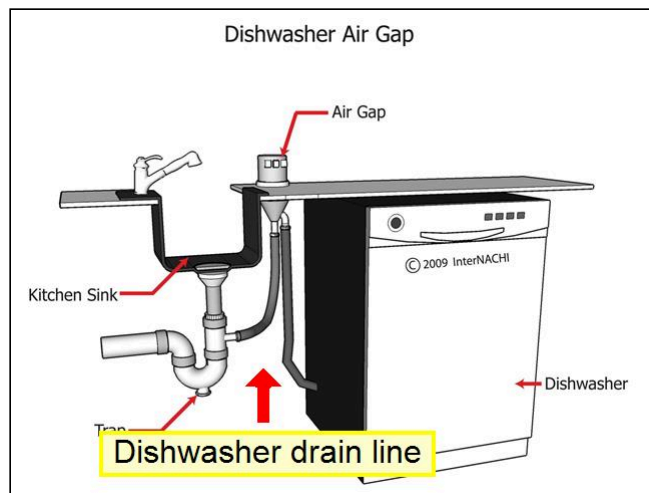
The dishwasher did not have a properly anchored high loop installed in the drain line at the time of the inspection. The high loop is designed to prevent wastewater from contaminating the dishwasher. This is an improper condition. The inspector recommends repair as soon as possible by a qualified contractor, or homeowner. This is an easy fix.

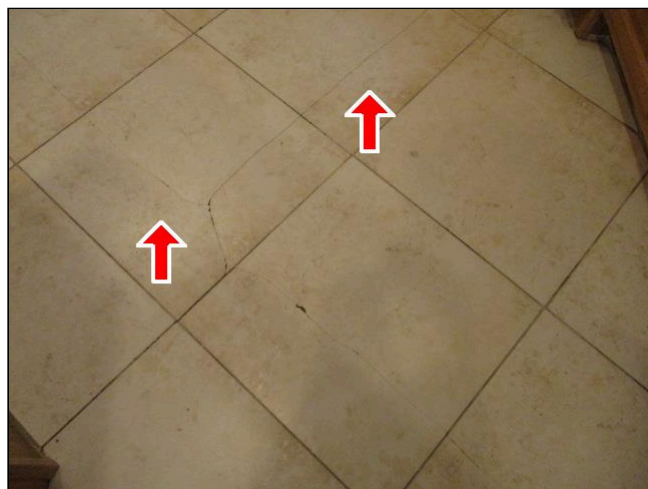
13.10 Item 1(Picture)

The kitchen floor had one or more broken tiles. The Inspector recommends repair by a qualified contractor. The Inspector recommends repair by a qualified contractor.

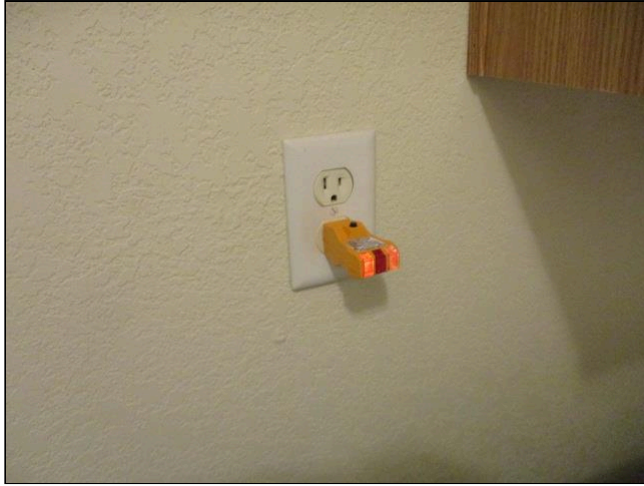
14.2 Item 1(Picture) laundry room

Electrical receptacles in the laundry room had no Ground Fault Circuit Interrupter (GFCI) protection. Although this condition may have been considered acceptable at the time the home was originally constructed, as knowledge of safe building practices has improved with the passage of time, building standards have changed to reflect current understanding. Consider having GFCI protection installed as a safety precaution for receptacles within 6 feet of a

plumbing fixture. This can be achieved by:

1. Replacing the current standard electrical receptacles with GFCI outlets;
2. Replacing the electrical receptacle nearest the overcurrent protection devices (breakers or fuses) protecting laundry room circuits with a GFCI receptacle; or
3. Replacing the breakers currently protecting the electrical circuits in the Laundry room with GFCI breakers.
