Inspection Report

Property Address:
61774 Alta loma Dr
Joshua Tree CA 92252

R & R Home Inspections

Date: 11/17/2022	Time: 10:00 AM	Report ID: 20221117altaloma
Property: 61774 Alta loma Dr Joshua Tree CA 92252	Customer:	Real Estate Professional: Victor Rosales Realty Masters & Associates

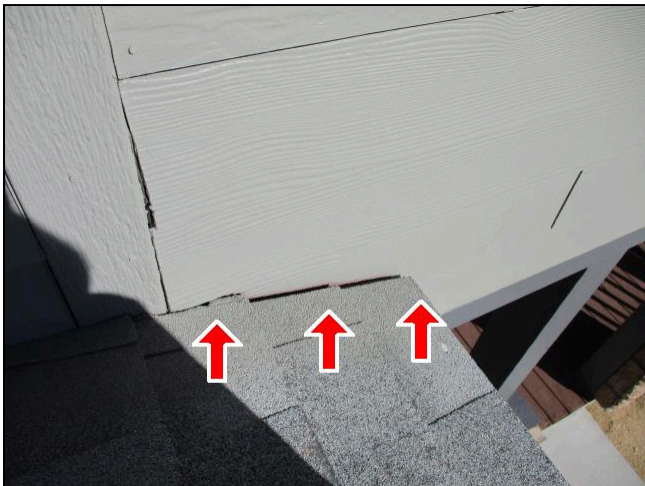
1.1 Item 1(Picture)

The home had no kick-out flashing installed where walls extended past roof edges. Kick-out flashing is designed and installed to divert water from behind the exterior wall covering at areas of the home where a sidewall extends out past a connecting roof eve. This condition may allow moisture intrusion of the exterior wall covering. Moisture intrusion of the wall structure can damage home materials and encourage the growth of mold. Long term moisture intrusion can cause structural damage from wood decay. The Inspector recommends that before the expiration of your Inspection Objection Deadline, you consult with a qualified roofing contractor to discuss options and costs for kickout flashing installation.

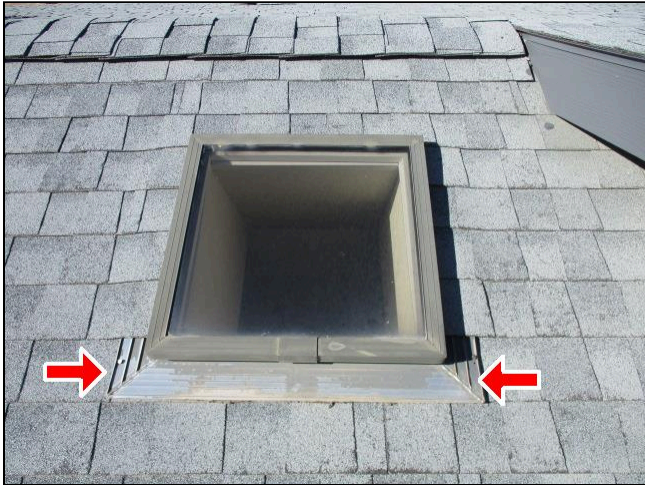
1.2 Item 1(Picture)

Exposed fasteners were observed at the skylight . The Inspector recommends an evaluation and any necessary work be performed by a qualified roofing contractor.

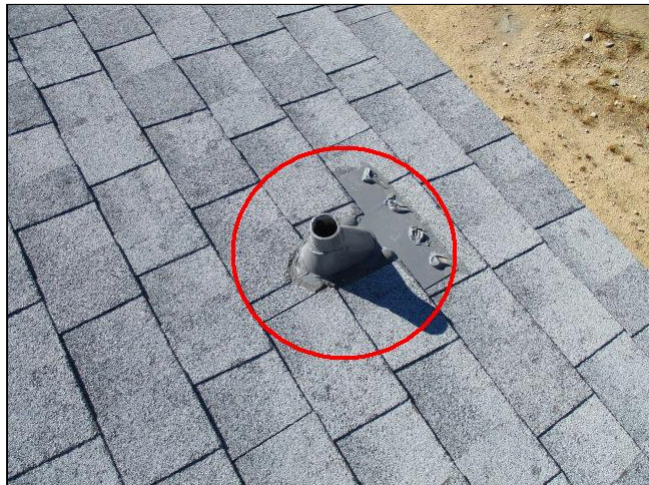
1.3 Item 1(Picture) left side (facing front)

A plumbing vent pipe serving the drain, waste and vent system had inadequate clearance above the roof. To help ensure that they perform according to their design, plumbing vent pipes should terminate a minimum of 6 inches above the roof or above the level of anticipated snow accumulation. The Inspector recommends correction by a qualified plumbing contractor.

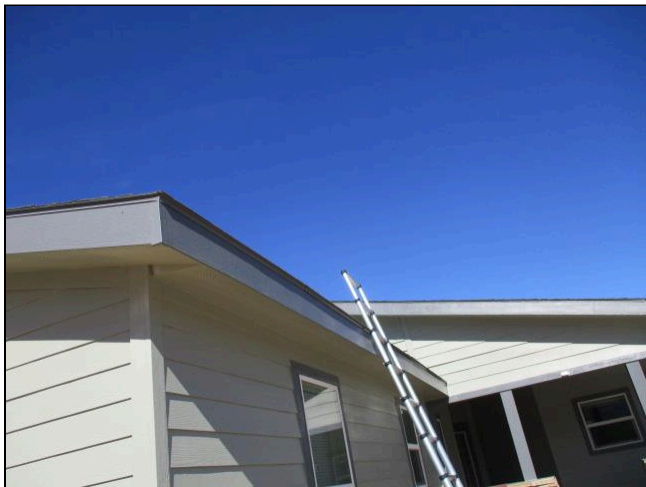
1.4 Item 1(Picture)

The home had no roof drainage system to channel roof drainage away from the foundation. The Inspector recommends installation of a roof drainage system to help protect the home structure and occupants.

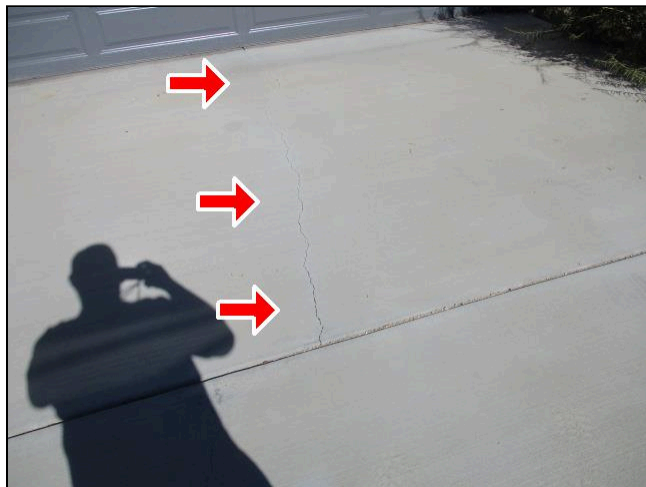
3.1 Item 1(Picture)

Common cracks ($\frac{1}{4}$ -inch or less) were visible in the driveway at the time of the inspection. Cracks exceeding $\frac{1}{4}$ inch should be filled with an appropriate sealant to avoid continued damage to the driveway surface from freezing moisture.

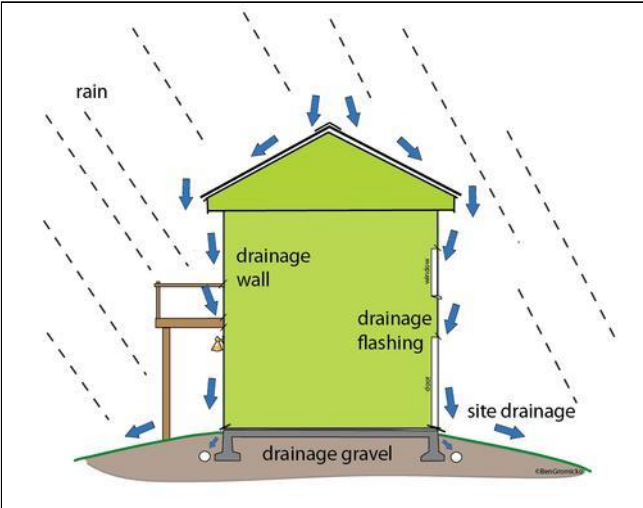
3.3 Item 5(Picture)

Swales at the side of the home were noted as being too shallow and can allow for water to flow out towards the foundation of the home during heavy rain fall or snow accumulation. It is recommended that the swales be cut deeper to prevent water accumulation next to the foundation walls and allow for sufficient drainage.

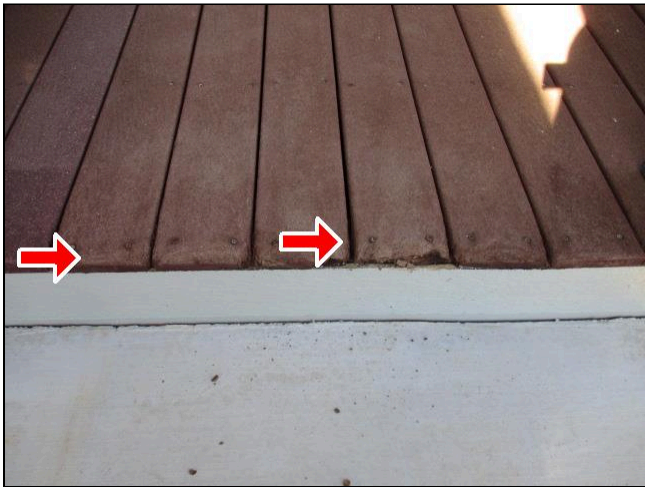
3.4 Item 1(Picture) front of home

This deck exhibited moderate general deterioration at the time of the inspection.

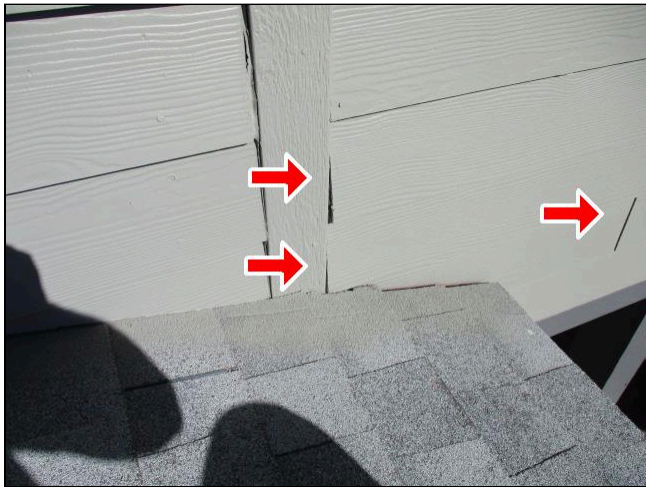
4.0 Item 1(Picture)

All joints between siding should be properly sealed. It is recommended to use elastomeric sealant.

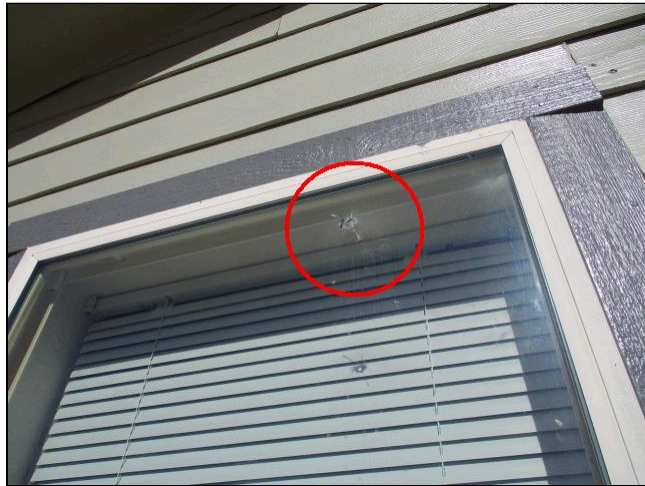
4.2 Item 1(Picture) front of home

A window at the front of the house had a broken glass.

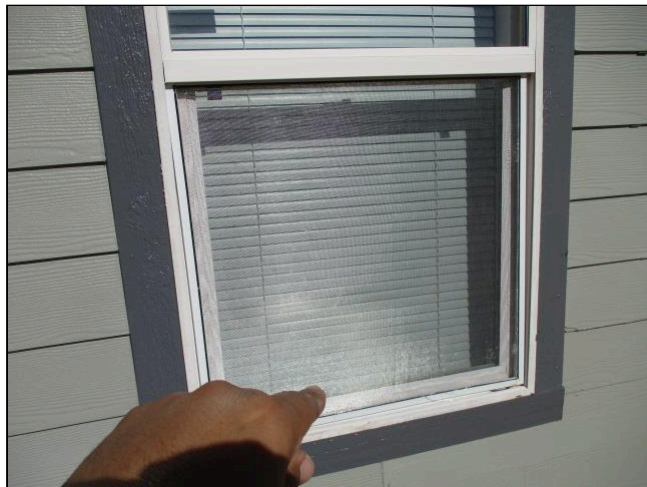
4.2 Item 3(Picture)

One or more of the window screens were observed to be damaged.

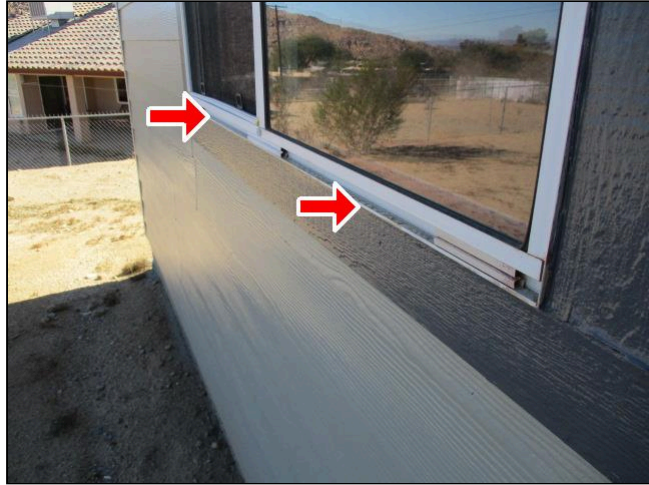
4.2 Item 4(Picture)

Window bottom rail damaged or missing. The Inspector recommends that before the expiration of your Inspection Objection Deadline you consult with a qualified contractor to discuss options and costs for correction.

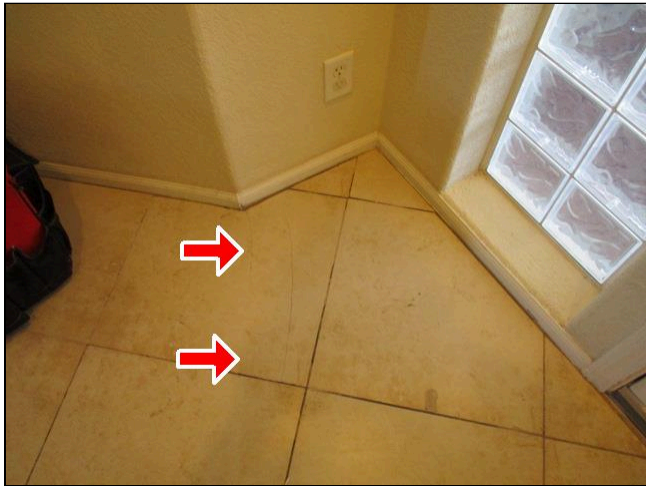
6.1 Item 1(Picture) Living Room

The living room had severe floor tile damage visible at the time of the inspection. You should consult with a qualified contractor to discuss options and costs for repair.

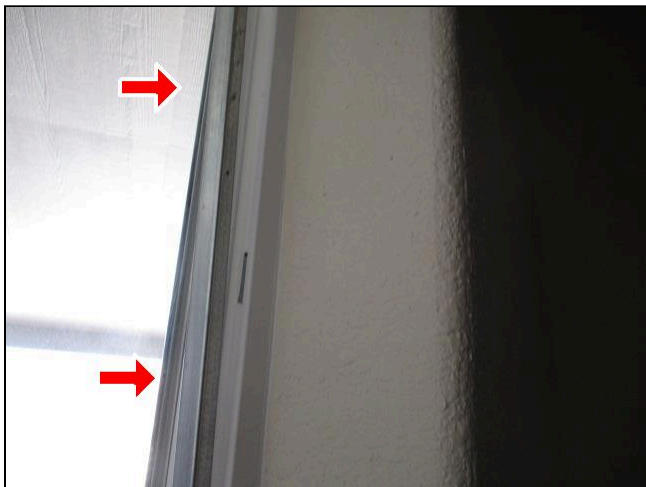
6.8 Item 1(Picture)

Few window in the interior are difficult to operate some are missing the window channel balance. Repair or replacement is recommended.

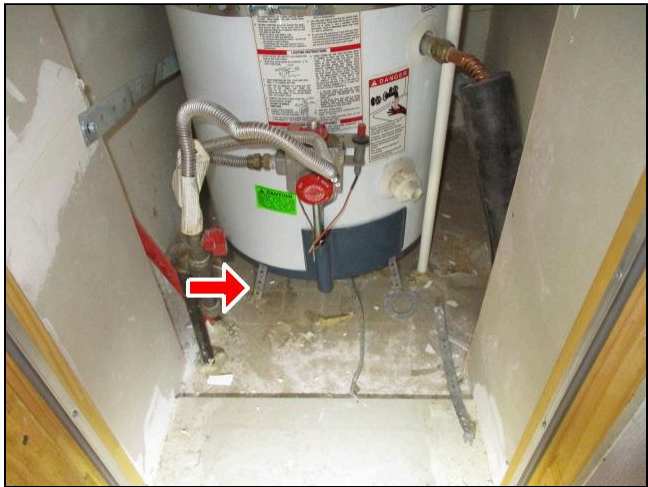
9.0 Item 1(Picture)

Drip pans are recommended below all hot water heaters,This will help contain leaks and prevent water damage.

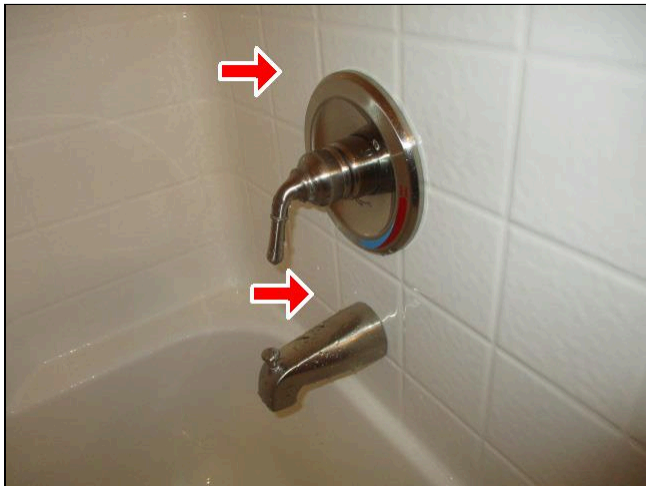
12.0 Item 1(Picture) hallway

The shower handle and spout is not sealed at the wall. This condition has the potential to allow water to leak back into the wall cavity.

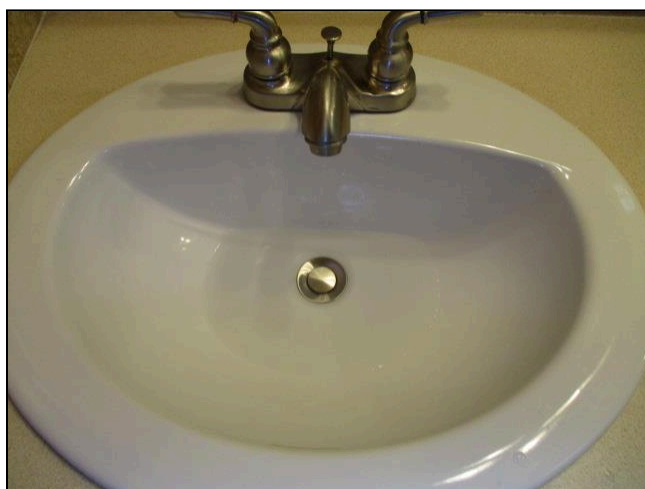
12.4 Item 1(Picture) hallway

The sink in the hallway was slow to drain. The blockage should be located and cleared by a qualified plumbing contractor.

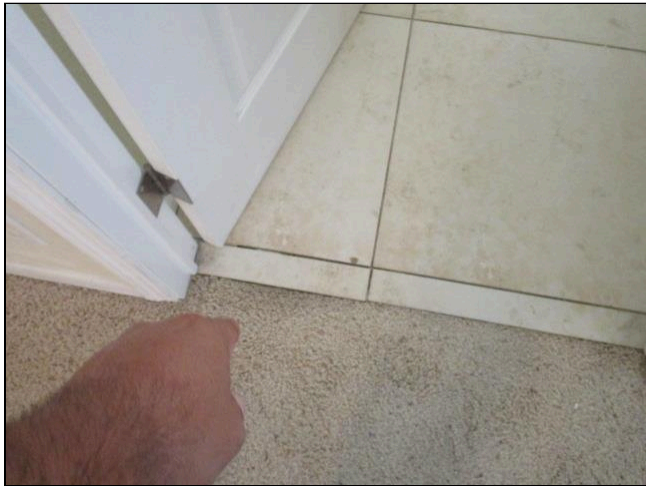
12.8 Item 1(Picture)

The master bathroom had severe floor tile damage visible at the time of the inspection. You should consult with a qualified contractor to discuss options and costs for repair.

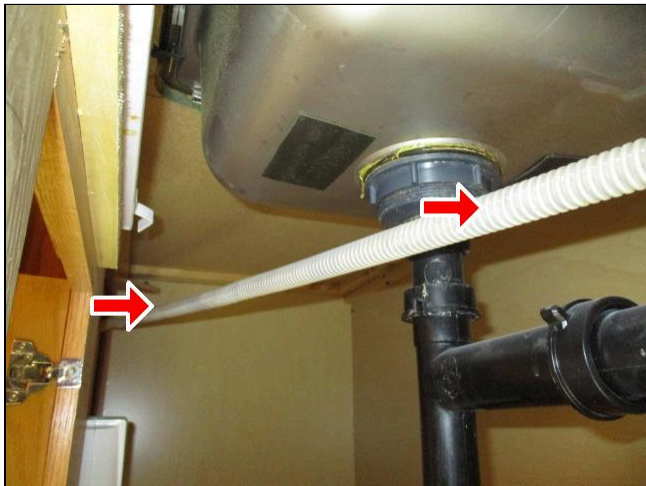
13.2 Item 3(Picture)

The dishwasher did not have a properly anchored high loop installed in the drain line at the time of the inspection. The high loop is designed to prevent wastewater from contaminating the dishwasher. This is an improper condition. The inspector recommends repair as soon as possible by a qualified contractor, or homeowner. This is an easy fix.

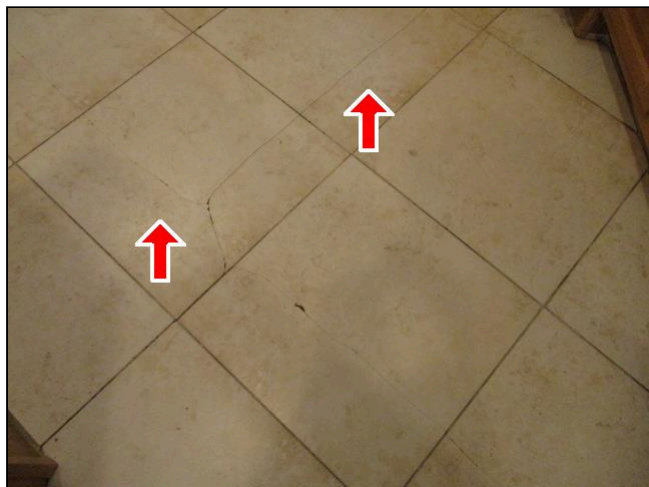
13.10 Item 1(Picture)

The kitchen floor had one or more broken tiles. The Inspector recommends repair by a qualified contractor. The Inspector recommends repair by a qualified contractor.

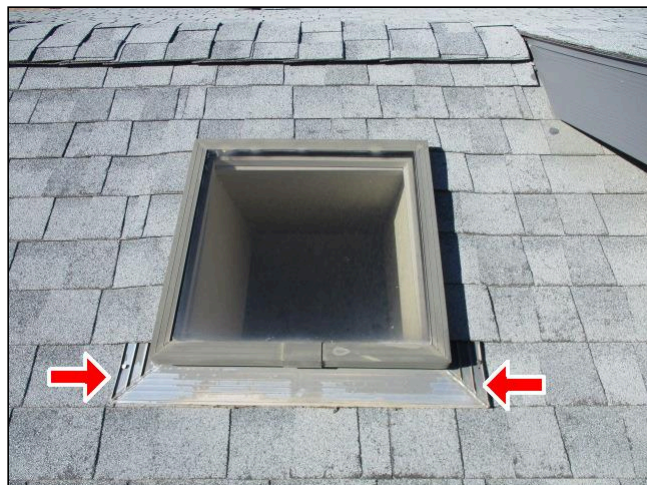
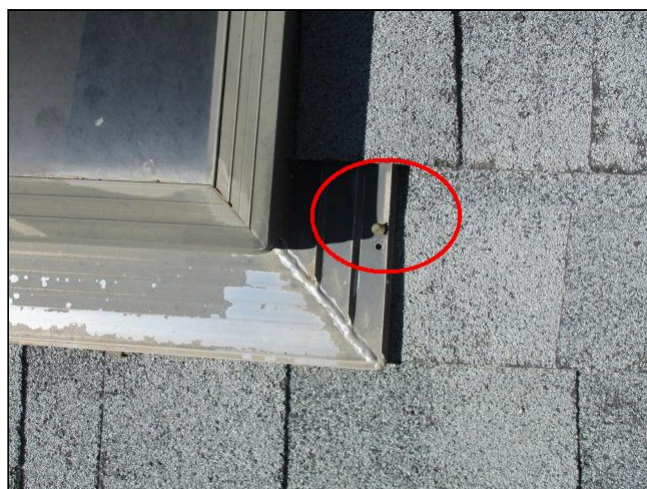
Exposed fasteners were observed at the skylight . The Inspector recommends an evaluation and any necessary work be performed by a qualified roofing contractor.

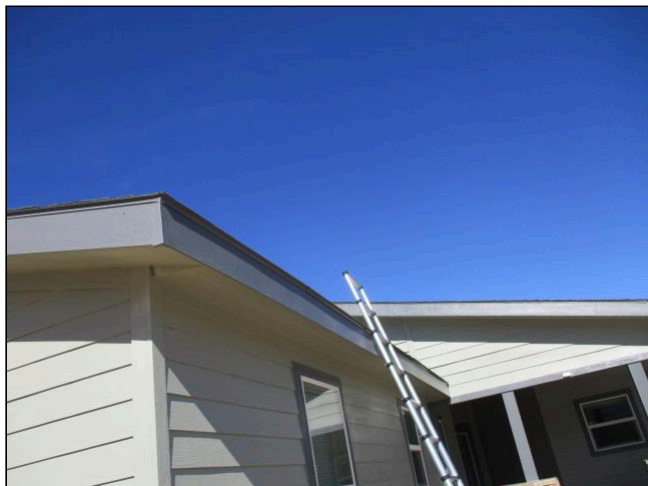
1.4 Item 1(Picture)

The home had no roof drainage system to channel roof drainage away from the foundation. The Inspector recommends installation of a roof drainage system to help protect the home structure and occupants.

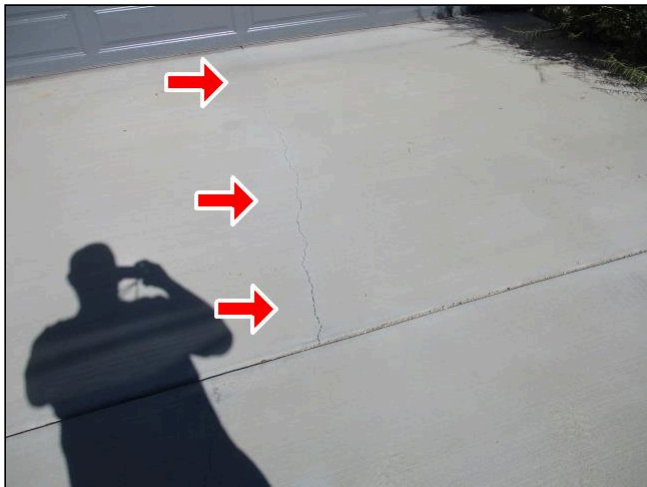
3.1 Item 1(Picture)

Common cracks (1/4-inch or less) were visible in the driveway at the time of the inspection. Cracks exceeding 1/4 inch should be filled with an appropriate sealant to avoid continued damage to the driveway surface from freezing moisture.

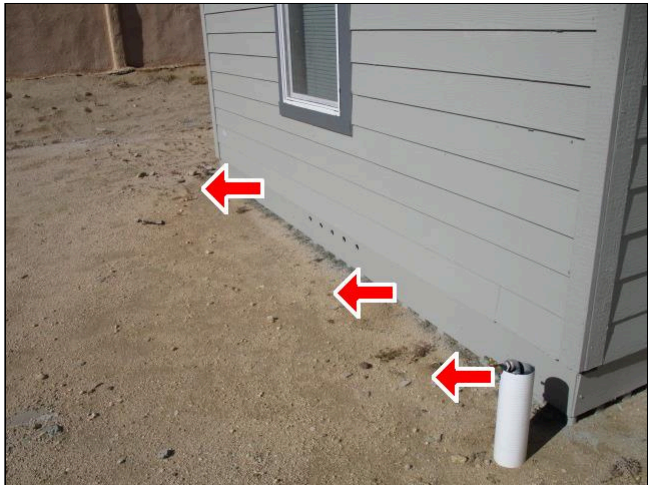
3.3 Item 2(Picture)

Swales at the side of the home were noted as being too shallow and can allow for water to flow out towards the foundation of the home during heavy rain fall or snow accumulation. It is recommended that the swales be cut deeper to prevent water accumulation next to the foundation walls and allow for sufficient drainage.

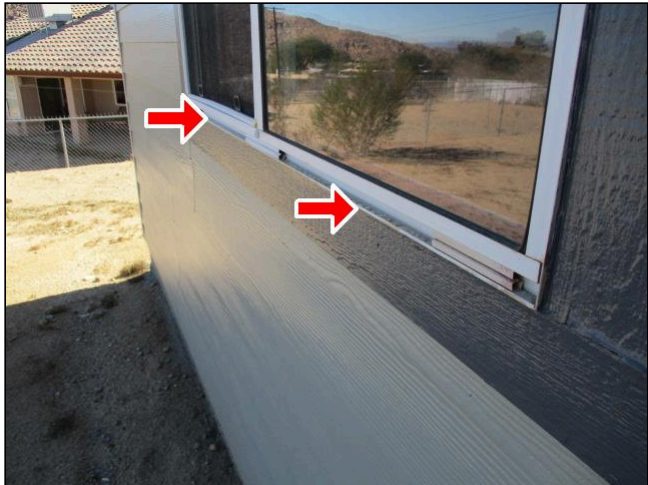
4.2 Item 4(Picture)

Window bottom rail damaged or missing. The Inspector recommends that before the expiration of your Inspection Objection Deadline you consult with a qualified contractor to discuss options and costs for correction.

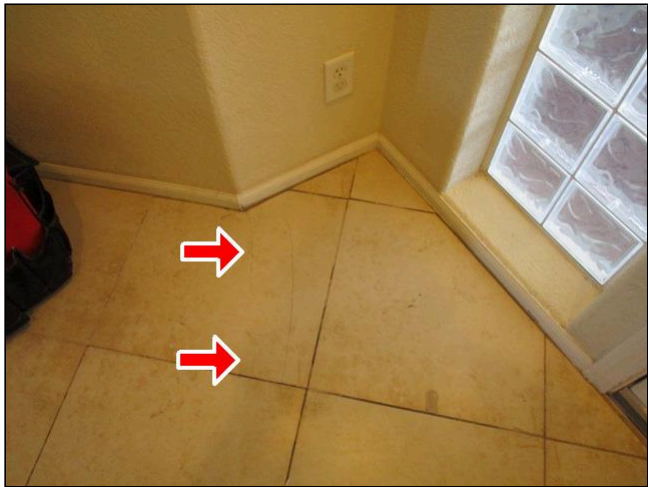
6.1 Item 1(Picture) Living Room

The living room had severe floor tile damage visible at the time of the inspection. You should consult with a qualified contractor to discuss options and costs for repair.

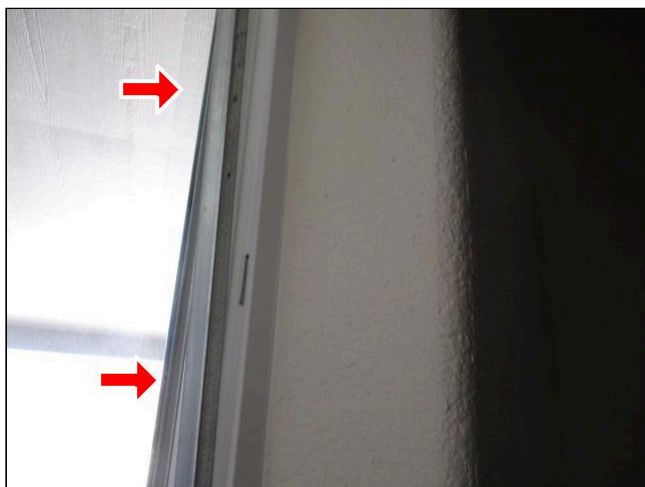
6.8 Item 1(Picture)

Few window in the interior are difficult to operate some are missing the window channel balance. Repair or replacement is recommended.

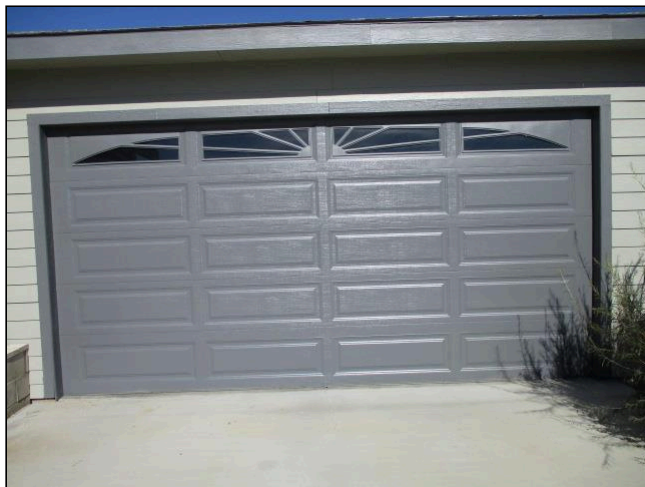
8.0 Item 1(Picture)

A garage vehicle door failed to reverse when a reasonable amount of resistance was applied. The Inspector recommends service by a qualified garage door contractor.

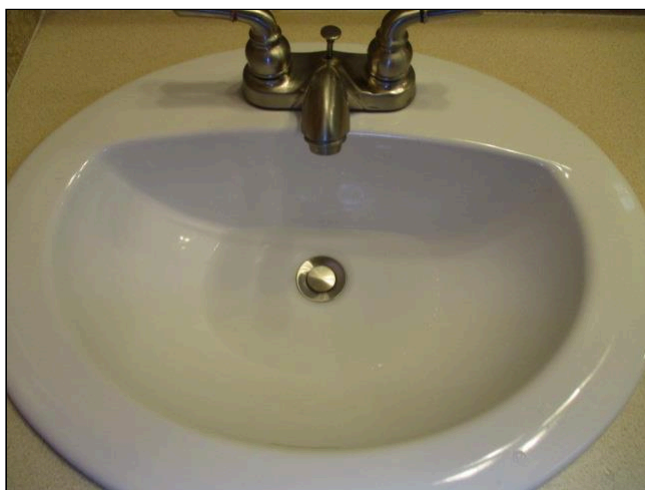
12.4 Item 1(Picture) hallway

The sink in the hallway was slow to drain. The blockage should be located and cleared by a qualified plumbing contractor.

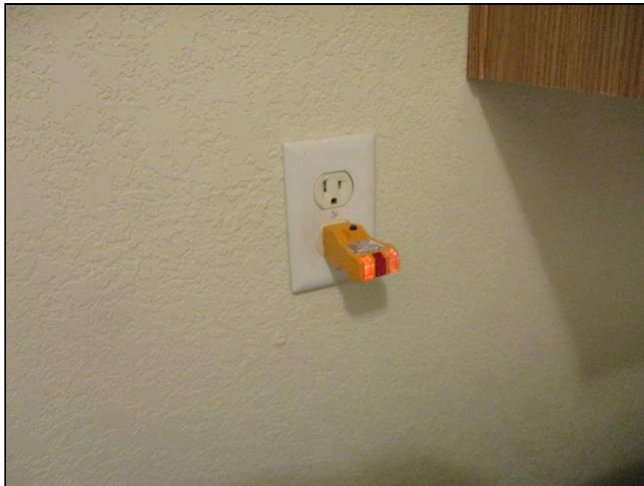
14.2 Item 1(Picture) laundry room

1. Replacing the current standard electrical receptacles with GFCI outlets;
2. Replacing the electrical receptacle nearest the overcurrent protection devices (breakers or fuses) protecting laundry room circuits with a GFCI receptacle; or
3. Replacing the breakers currently protecting the electrical circuits in the Laundry room with GFCI breakers.
