Inspection Report

Property Address:
61774 Alta loma Dr
Joshua Tree CA 92252

R & R Home Inspections

Date: 11/17/2022	Time: 10:00 AM	Report ID: 20221117altaloma
Property: 61774 Alta loma Dr Joshua Tree CA 92252	Customer:	Real Estate Professional: Victor Rosales Realty Masters & Associates

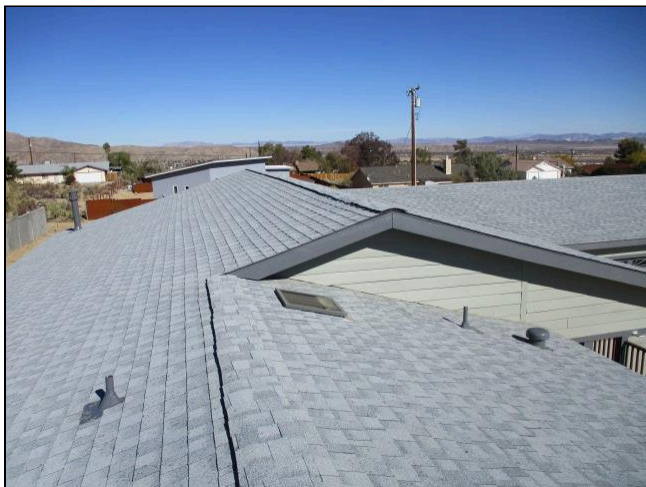
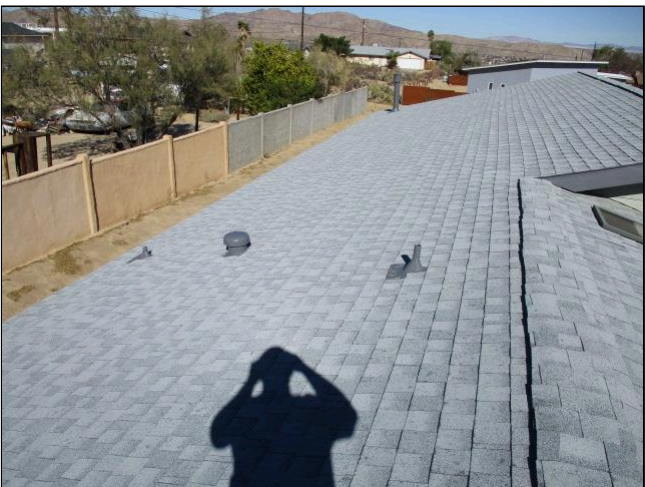
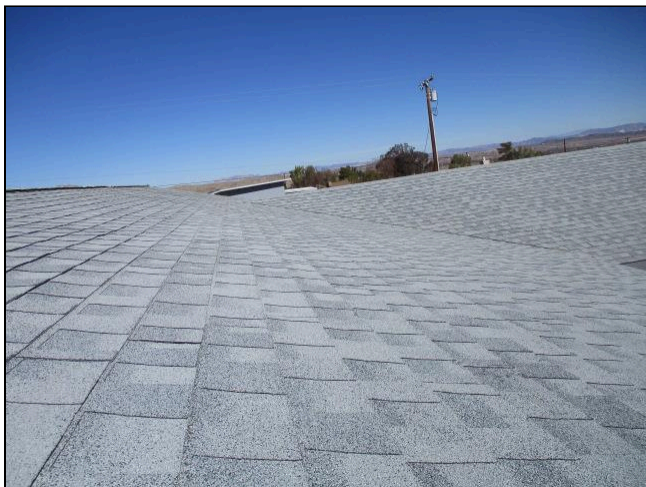
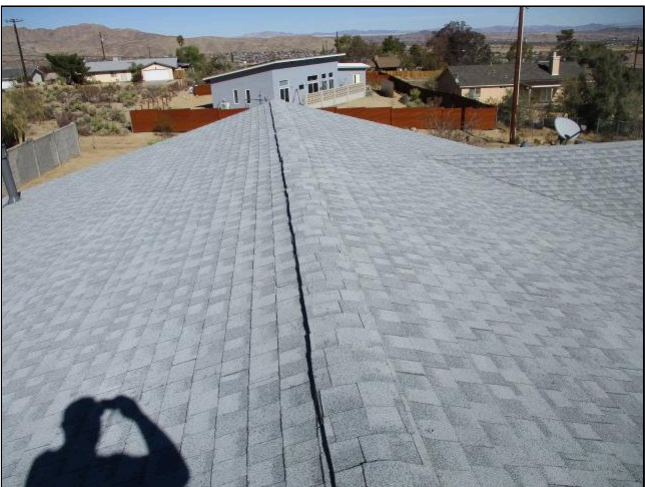
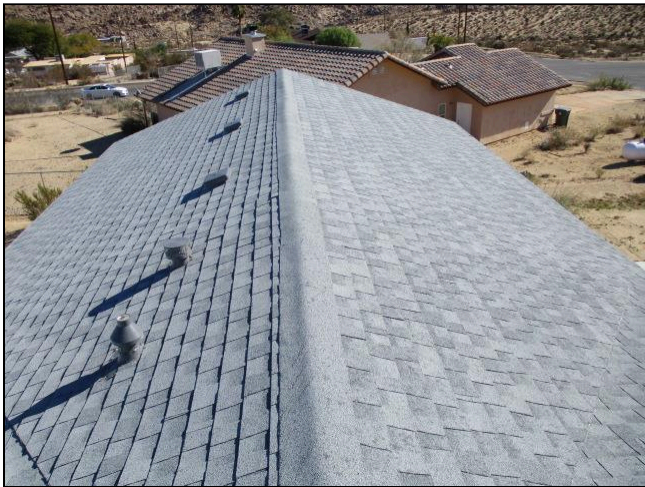
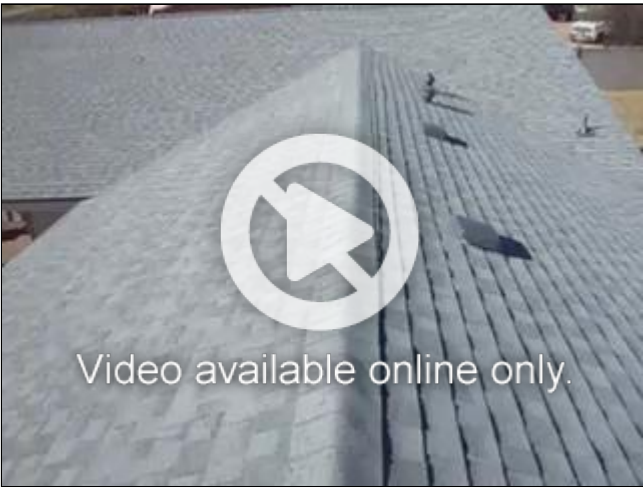
The inspector observed no deficiencies when inspecting the roof.

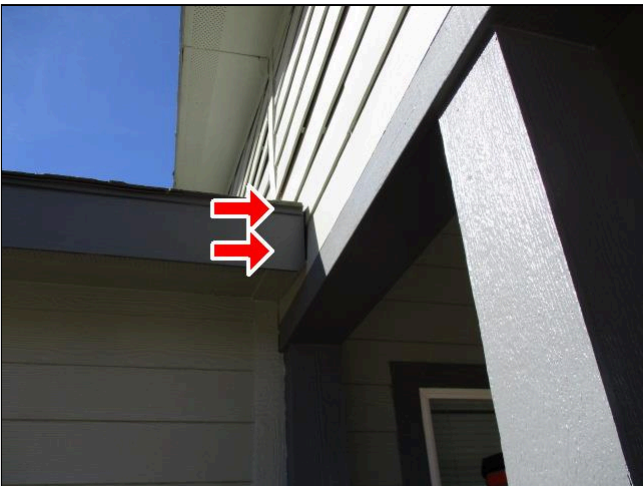
1.1 Item 2(Picture)

The home had no kick-out flashing installed where walls extended past roof edges. Kick-out flashing is designed and installed to divert water from behind the exterior wall covering at areas of the home where a sidewall extends out past a connecting roof eve. This condition may allow moisture intrusion of the exterior wall covering. Moisture intrusion of the wall structure can damage home materials and encourage the growth of mold. Long term moisture intrusion can cause structural damage from wood decay. The Inspector recommends that before the expiration of your Inspection Objection Deadline, you consult with a qualified roofing contractor to discuss options and costs for kickout flashing installation.

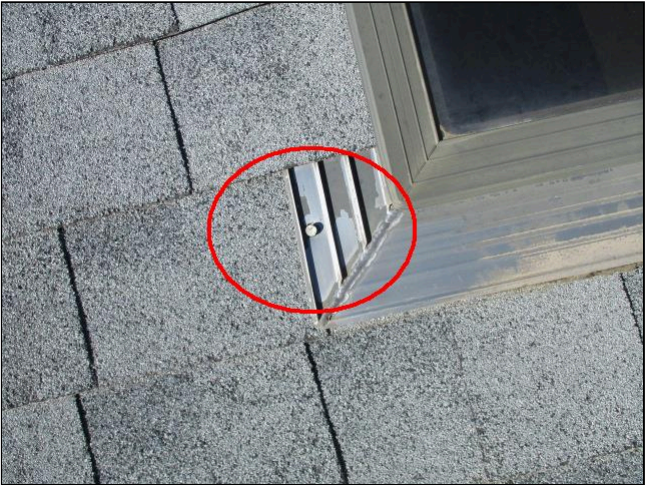
1.2 Item 2(Picture)

Exposed fasteners were observed at the skylight . The Inspector recommends an evaluation and any necessary work be performed by a qualified roofing contractor.

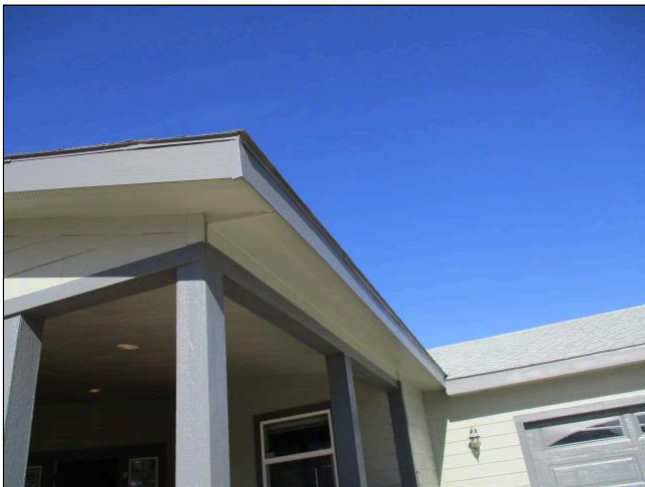
1.4 Item 2(Picture)

The home had no roof drainage system to channel roof drainage away from the foundation. The Inspector recommends installation of a roof drainage system to help protect the home structure and occupants.

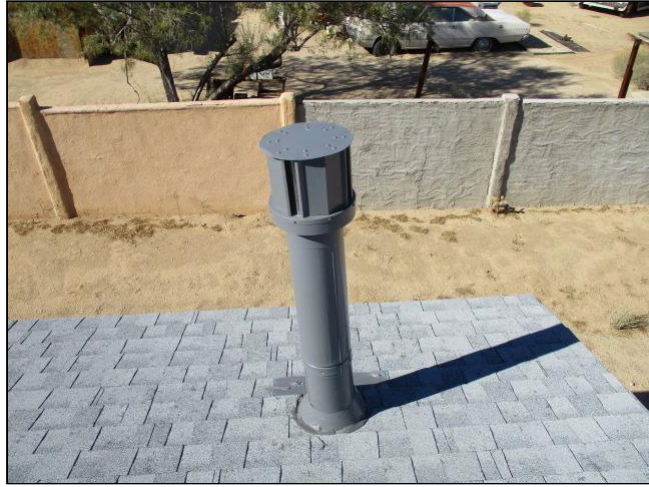
1.5 Item 1(Picture)

No deficiencies noted at time of inspection.

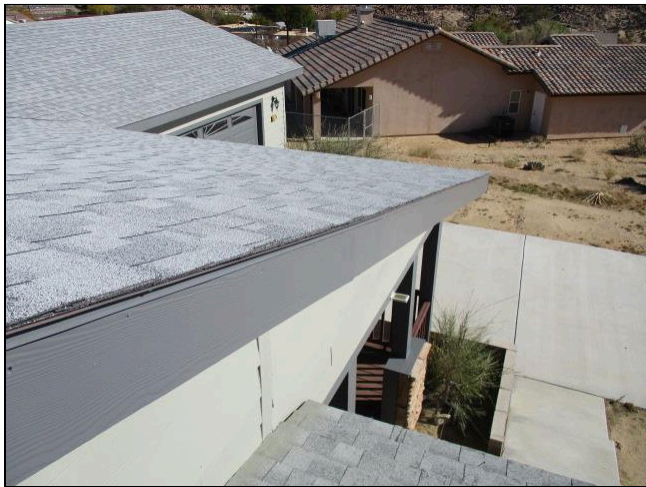
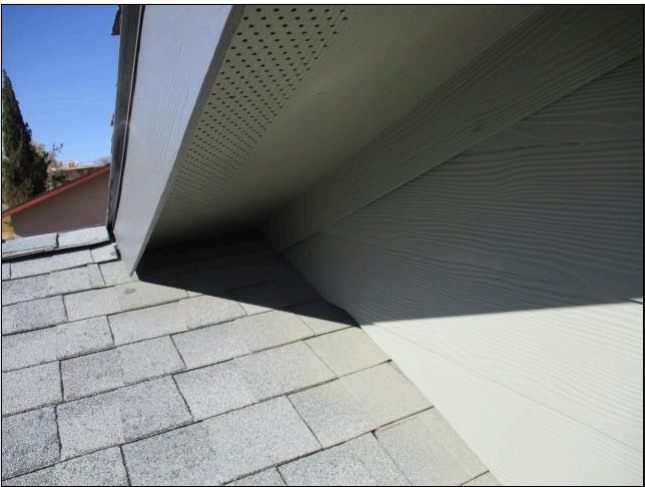
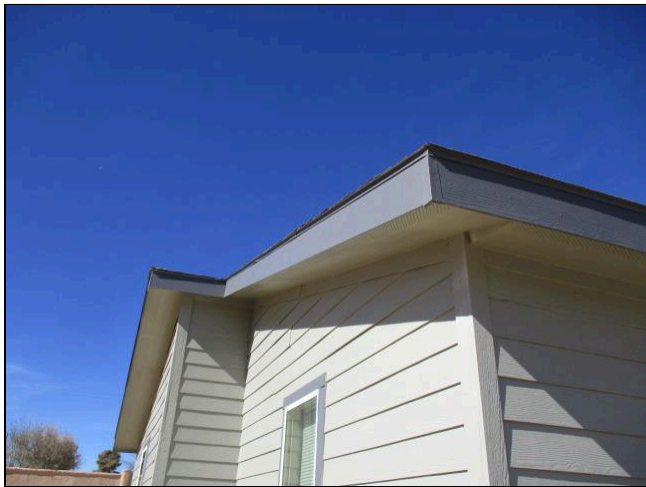
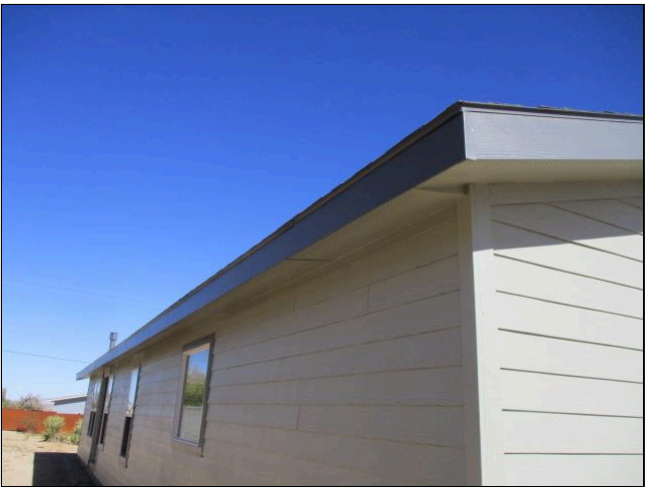
No deficiencies noted at time of inspection.

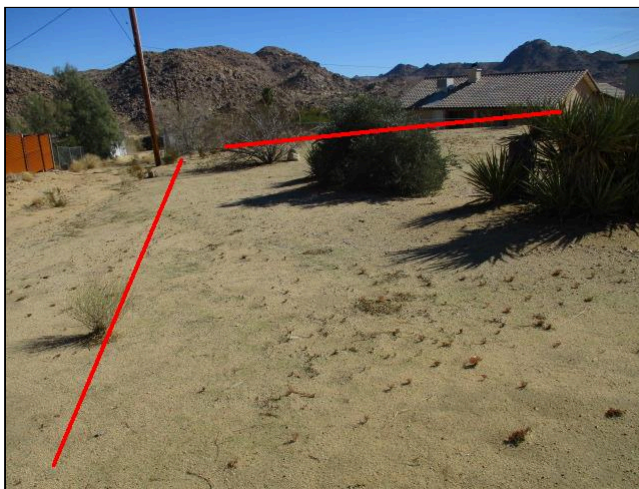
3.2 Item 1(Picture)

No fence was installed on the north and east side of the property.

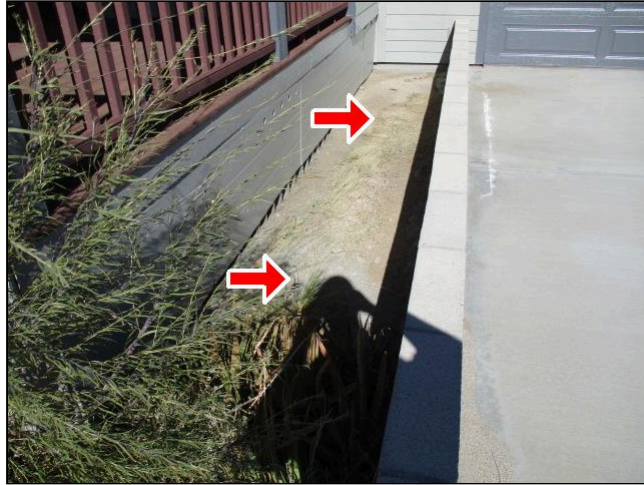
3.3 Item 1(Picture)

Marginal site drainage was observed next to the deck structure. Proper drainage is needed to help prevent water from standing and/or ponding next to the crawl space and foundation.

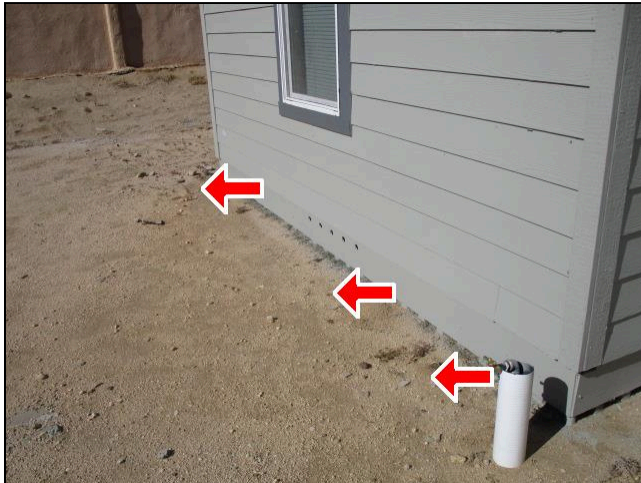
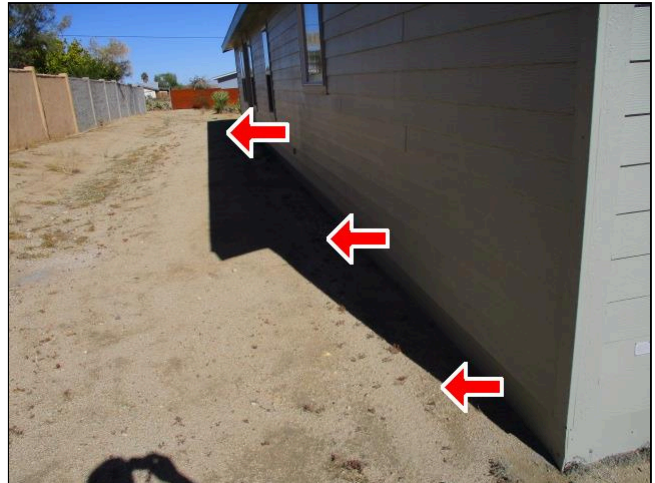
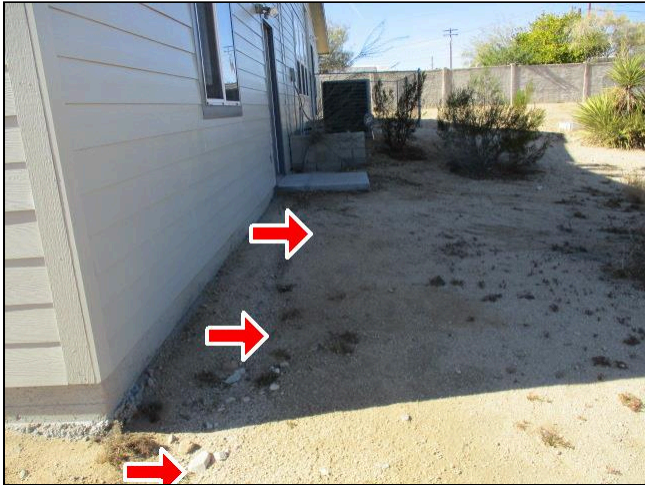
Swales at the side of the home were noted as being too shallow and can allow for water to flow out towards the foundation of the home during heavy rain fall or snow accumulation. It is recommended that the swales be cut deeper to prevent water accumulation next to the foundation walls and allow for sufficient drainage.

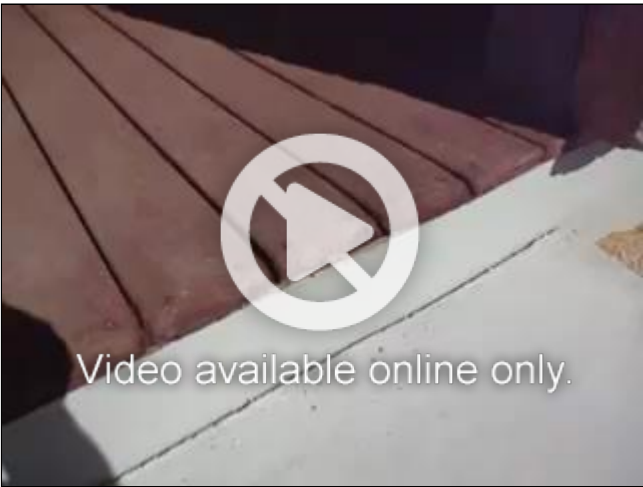
3.4 Item 2(Video)

This deck exhibited moderate general deterioration at the time of the inspection.

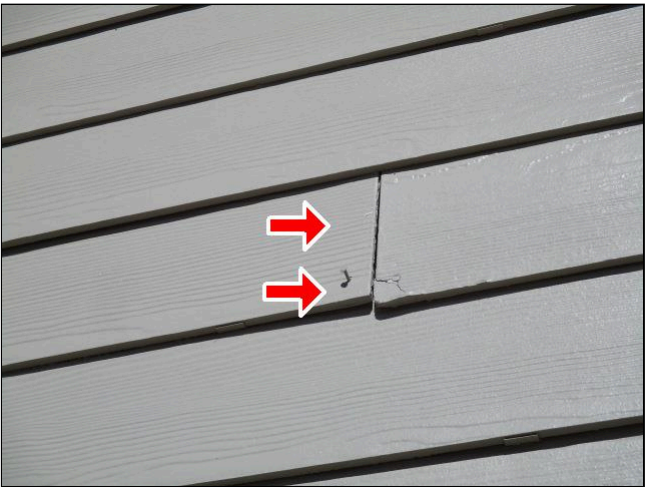
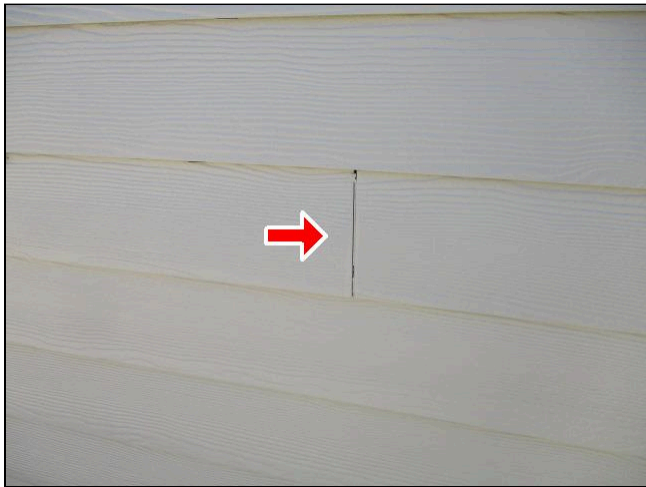
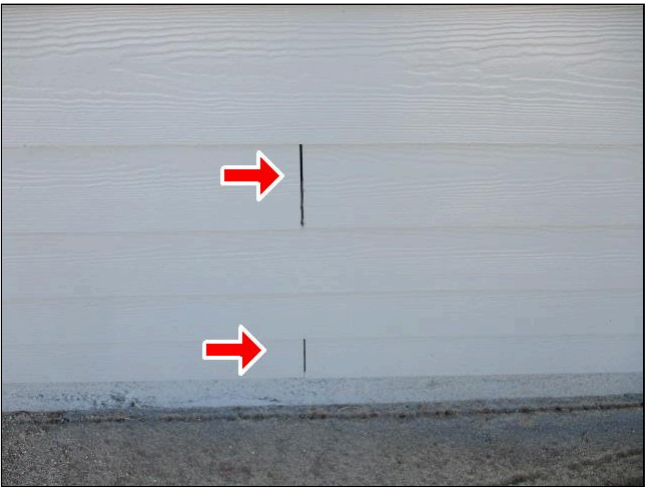
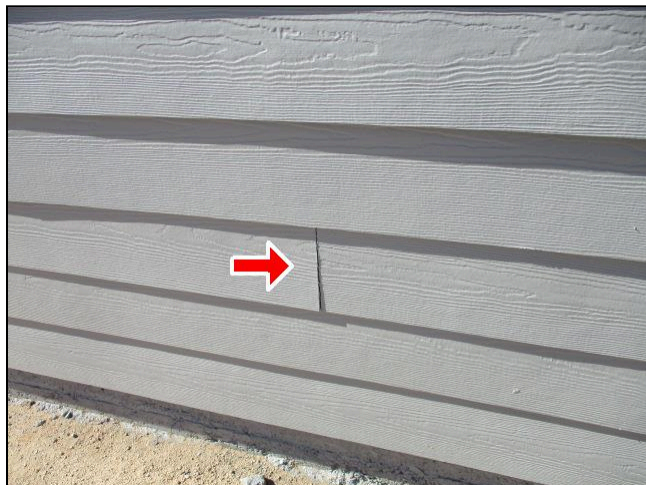
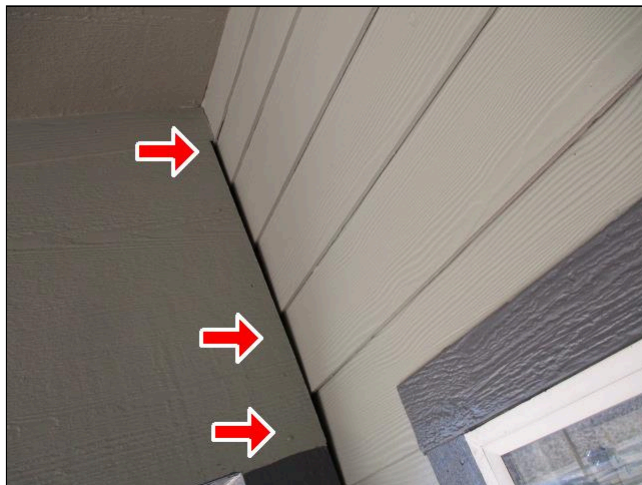
All joints between siding should be properly sealed. It is recommended to use elastomeric sealant.

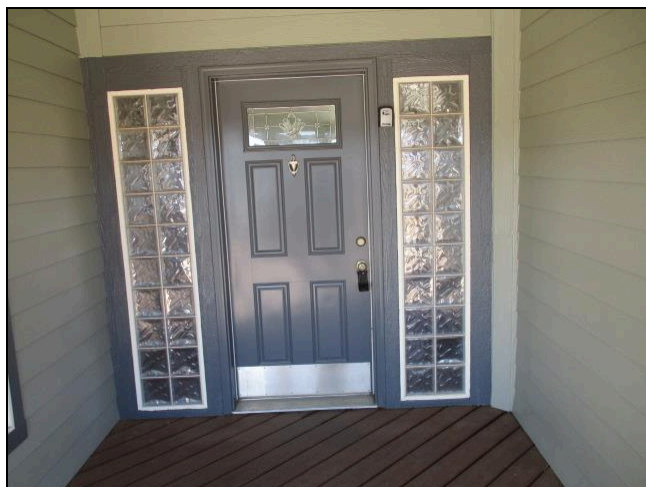
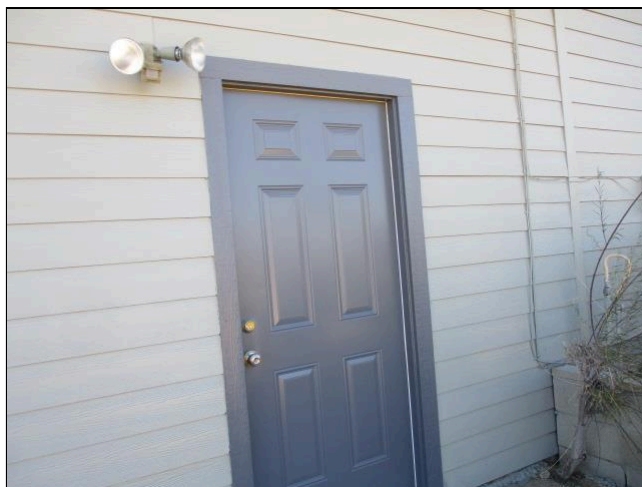
The inspector observed no deficiencies.

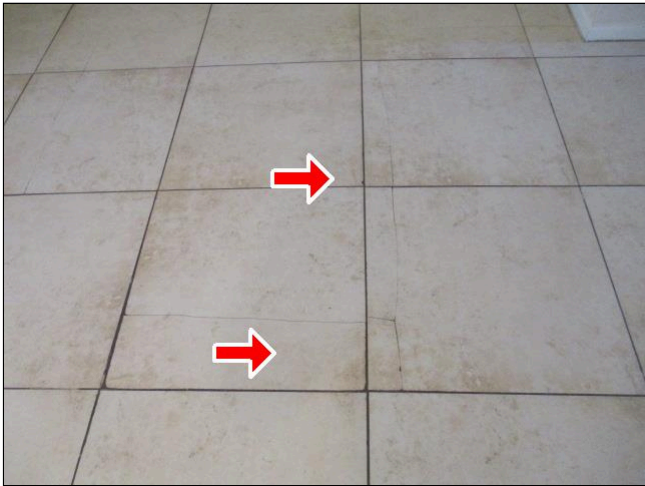
6.1 Item 1(Picture) Living Room

The living room had severe floor tile damage visible at the time of the inspection. You should consult with a qualified contractor to discuss options and costs for repair.

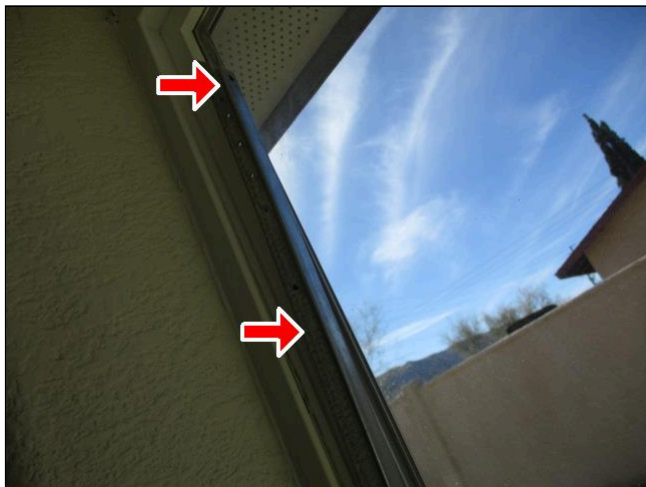
6.8 Item 1(Picture)

Few window in the interior are difficult to operate some are missing the window channel balance. Repair or replacement is recommended.

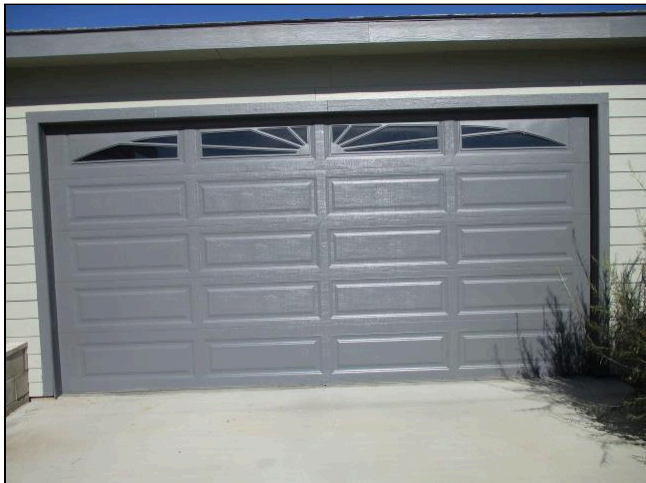
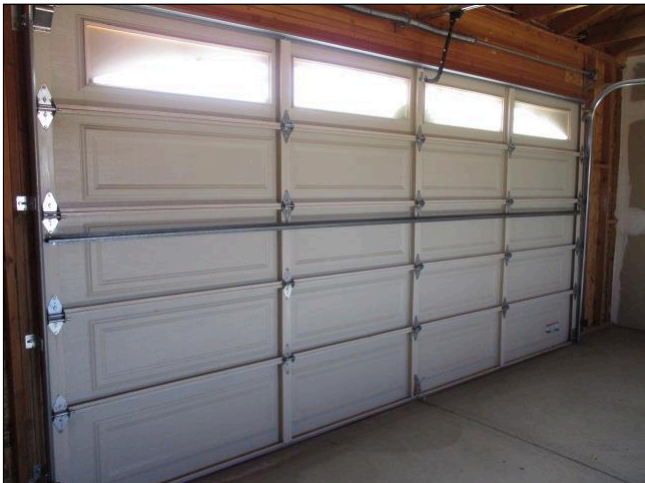
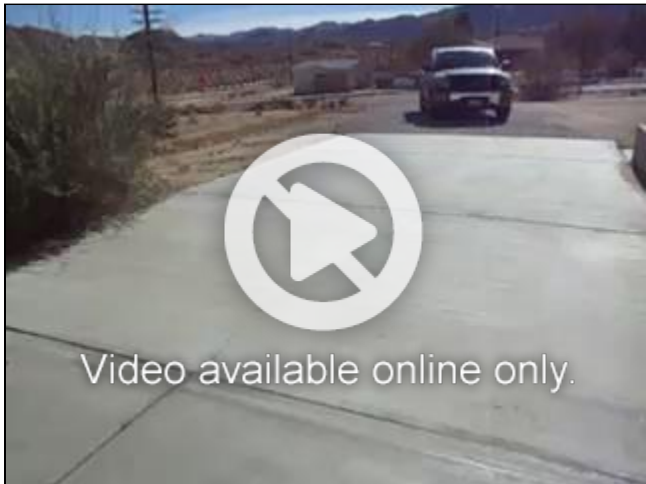
A garage vehicle door failed to reverse when a reasonable amount of resistance was applied. The Inspector recommends service by a qualified garage door contractor.

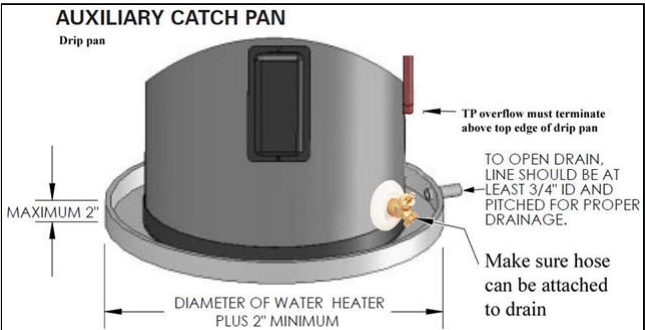
9.0 Item 2(Picture)

Drip pans are recommended below all hot water heaters,This will help contain leaks and prevent water damage.

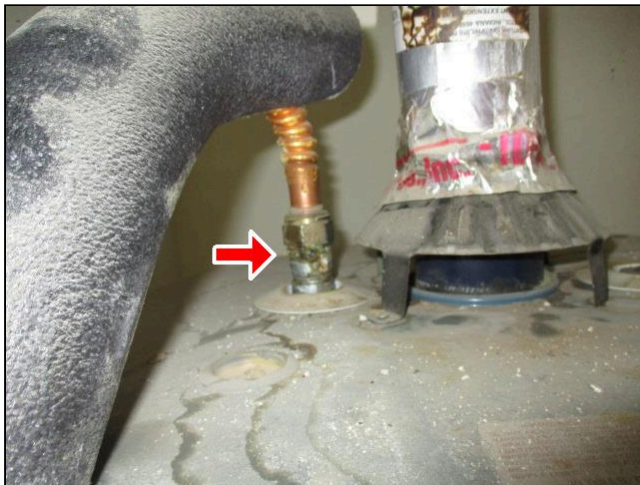
9.0 Item 3(Picture)

Corrosion visible on water pipes connected to this water heater appeared to be the result of dissimilar metals in contact with each other. This condition can cause galvanic corrosion. The Inspector recommends installation of a dielectric union by a qualified plumbing contractor to help prevent further corrosion, deterioration and/or leakage made possible by this condition.

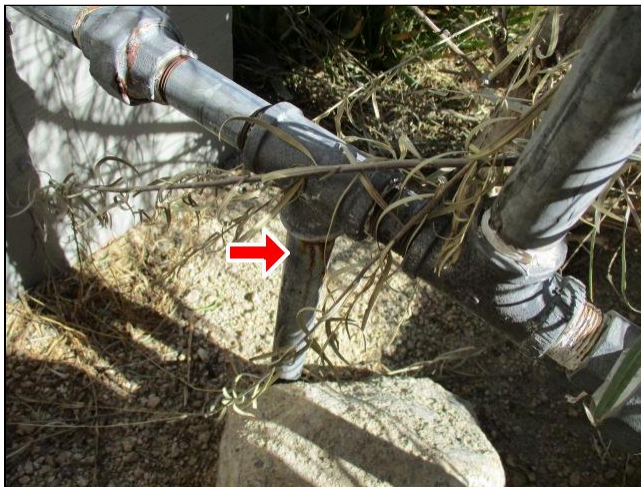
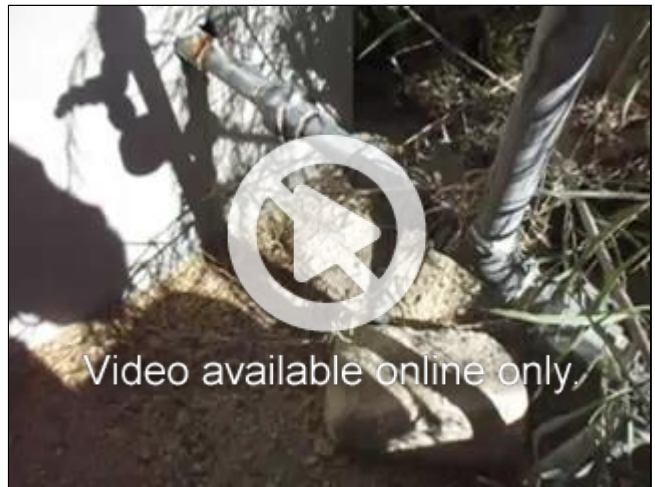
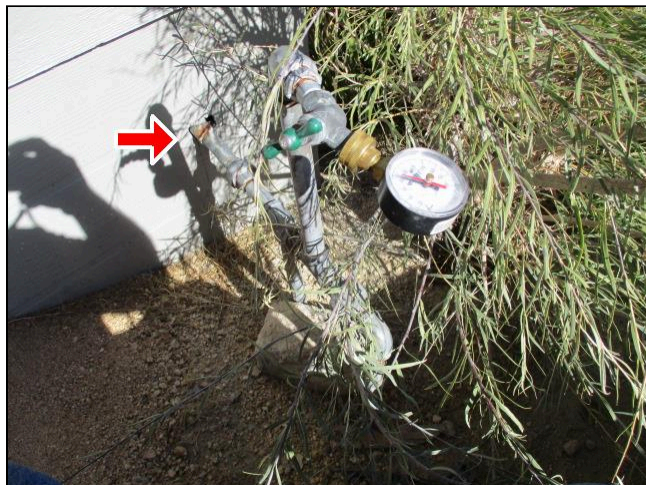
Corroded supply pipes . The Inspector recommends replacement by a qualified contractor to prevent future damage.

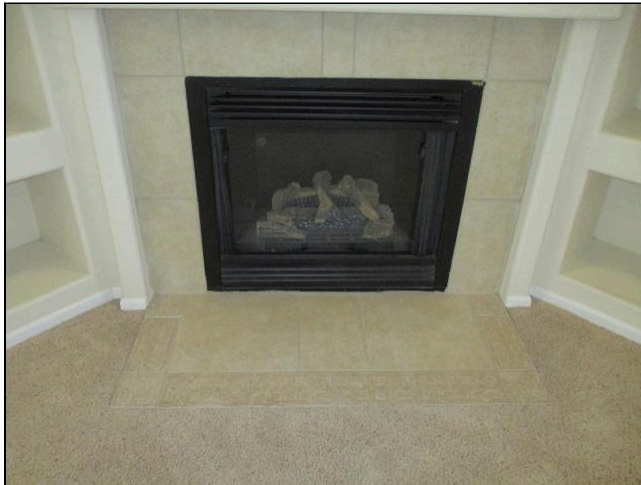
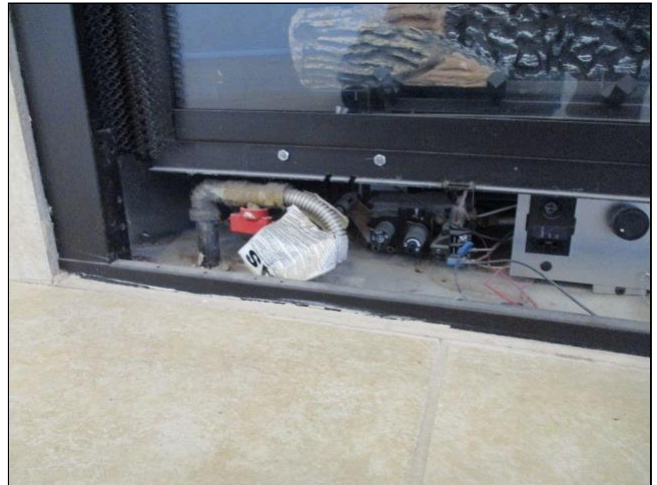
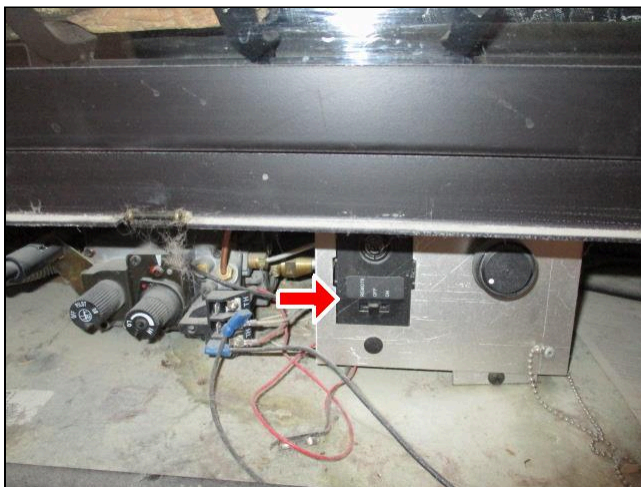
The fireplace in the living room was turned off at the primary controls. Changing settings at the primary controls lies beyond the scope of the General Home Inspection. You should ask the seller to demonstrate the functionality of this fireplace or have it inspected by a specialist.

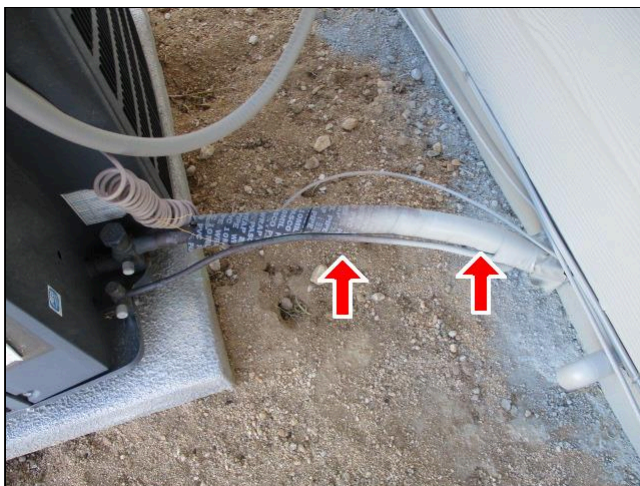
11.0 Item 11(Picture) rear of home

**Damaged, deteriorated and/or
missing insulation on the
refrigerant lines should be repaired
or replaced at the outside
condenser**

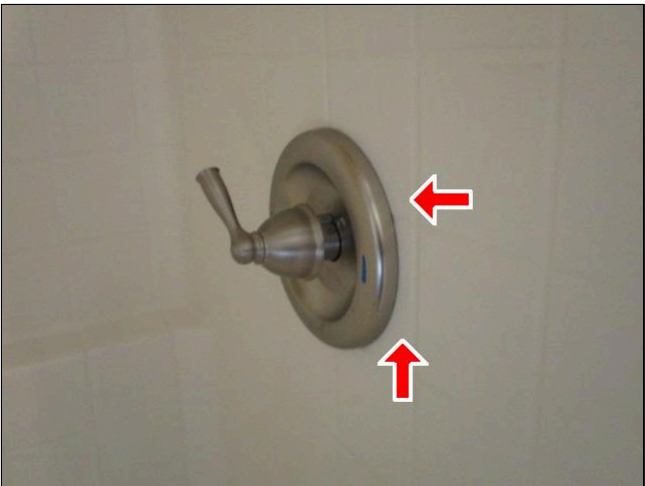
12.0 Item 2(Picture) master bathroom

The shower handle and spout is not sealed at the wall. This condition has the potential to allow water to leak back into the wall cavity.

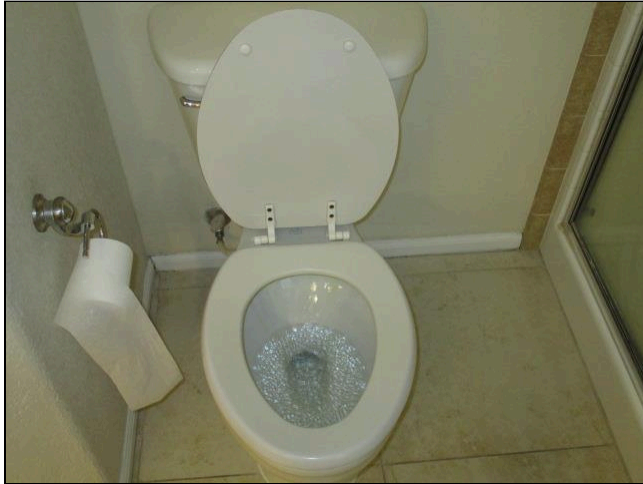
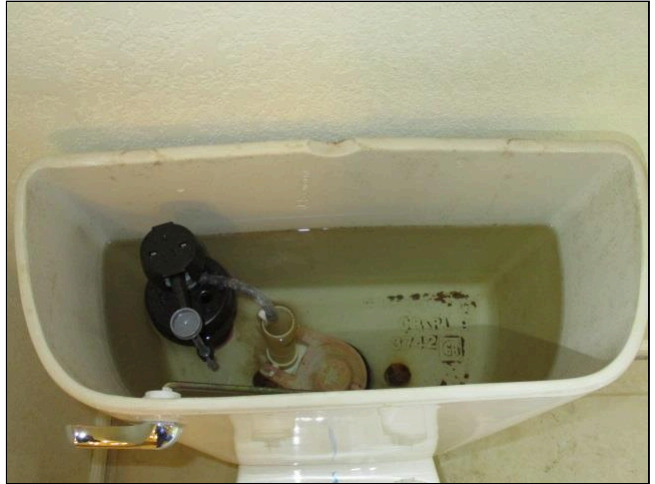
The toilet in the Master bathroom ran continuously at the time of the inspection. This usually indicates a failed flapper valve, the need for float mechanism adjustment or water leaking from the water tank into the bowl. Under some conditions, in homes with water supplied from a well, this condition can result in running the well dry and burning out the pump, requiring expensive repair. You should be diligent in maintaining toilet tank mechanisms in the future to avoid pump damage.

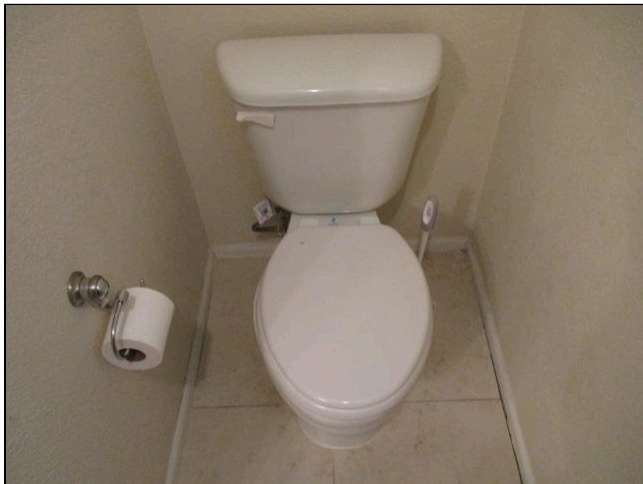
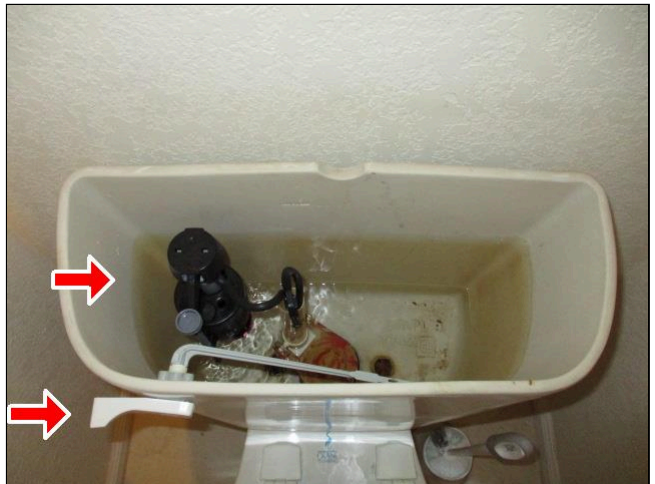
The master bathroom, the toilet handle did not return to position, indicating that components in the tank need adjustment or replacement.

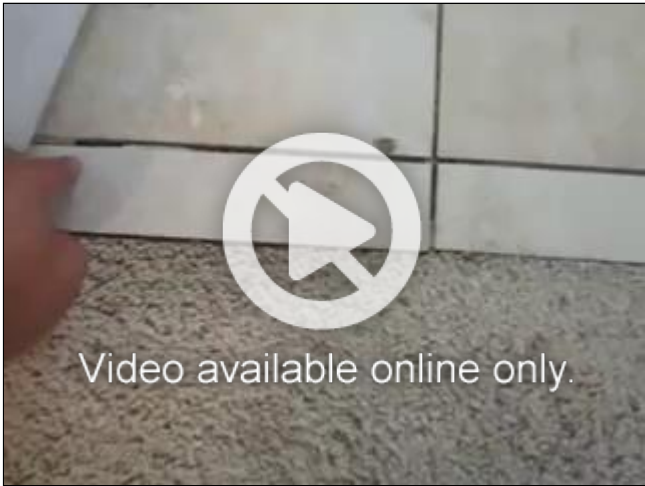
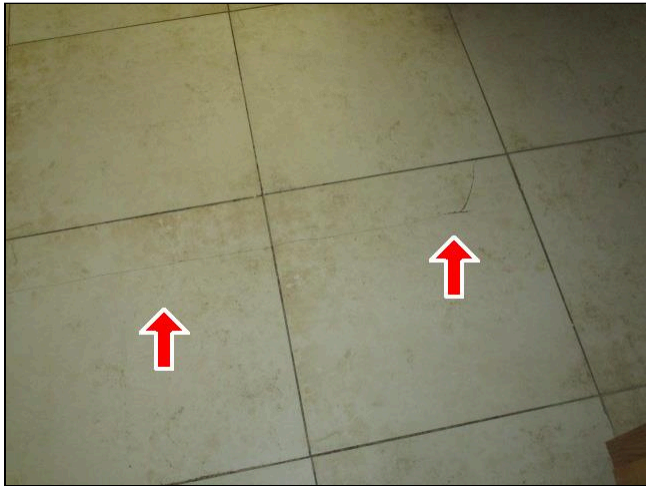
The master bathroom had severe floor tile damage visible at the time of the inspection. You should consult with a qualified contractor to discuss options and costs for repair.

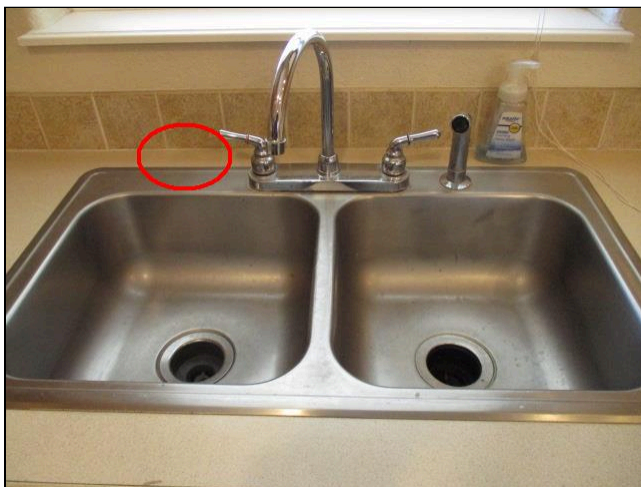
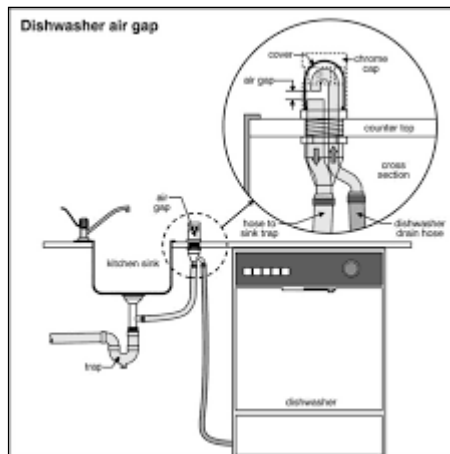
The dishwasher did not appear to have an anti-siphon device installed in the drain line. Anti-siphon devices are installed to prevent wastewater from the dishwasher from being siphoned back into the dishwasher and contaminating its contents. The Inspector recommends an anti-siphon device be installed by a qualified technician.

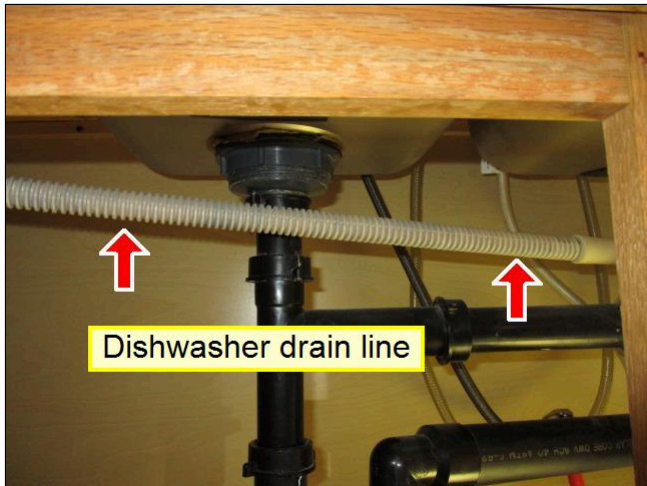
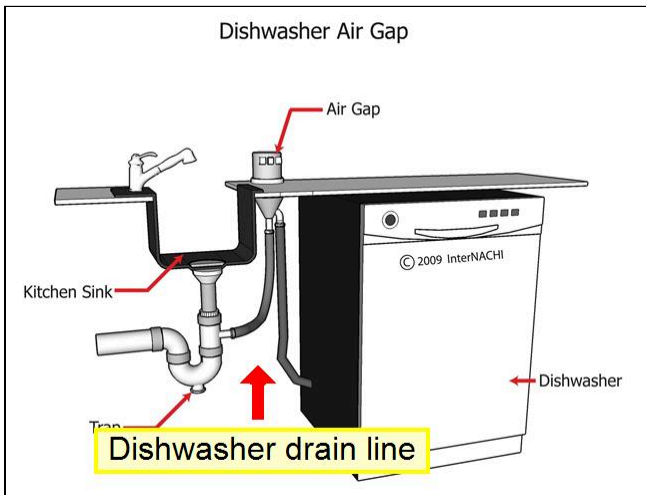
The dishwasher did not have a properly anchored high loop installed in the drain line at the time of the inspection. The high loop is designed to prevent wastewater from contaminating the dishwasher. This is an improper condition. The inspector recommends repair as soon as possible by a qualified contractor, or homeowner. This is an easy fix.

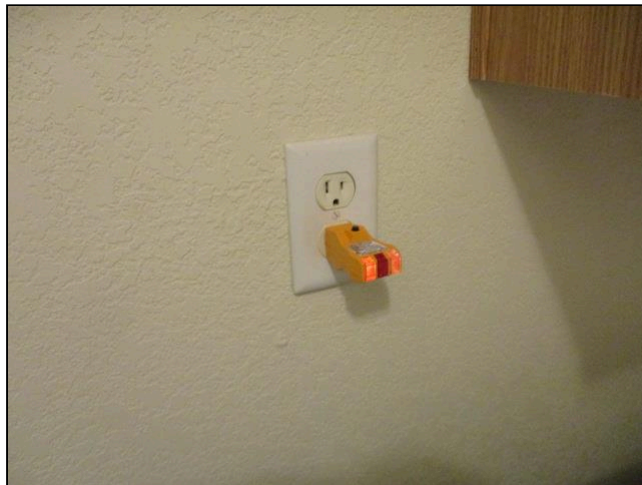
14.2 Item 1(Picture) laundry room

Electrical receptacles in the laundry room had no Ground Fault Circuit Interrupter (GFCI) protection. Although this condition may have been considered acceptable at the time the home was originally constructed, as knowledge of safe building practices has improved with the passage of time, building standards have changed to reflect current understanding. Consider having GFCI protection installed as a safety precaution for receptacles within 6 feet of a plumbing fixture. This can be achieved by:

1. Replacing the current standard electrical receptacles with GFCI outlets;
2. Replacing the electrical receptacle nearest the overcurrent protection devices (breakers or fuses) protecting laundry room circuits with a GFCI receptacle; or
3. Replacing the breakers currently protecting the electrical circuits in the Laundry room with GFCI breakers.

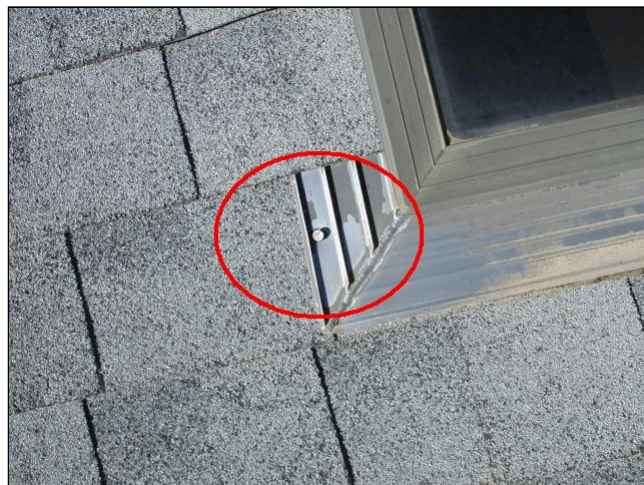
1.2 Item 2(Picture)

Exposed fasteners were observed at the skylight . The Inspector recommends an evaluation and any necessary work be performed by a qualified roofing contractor.

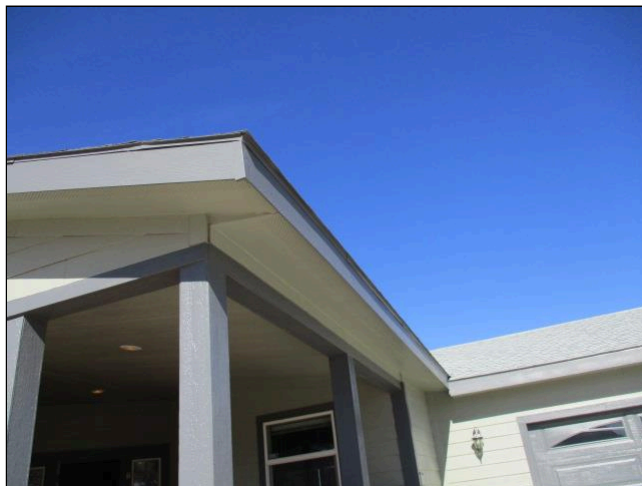
1.4 Item 2(Picture)

The home had no roof drainage system to channel roof drainage away from the foundation. The Inspector recommends installation of a roof drainage system to help protect the home structure and occupants.

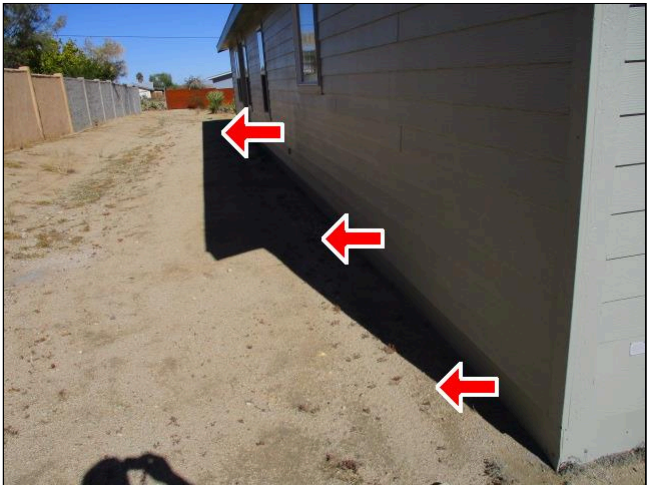
3.3 Item 3(Picture)

Swales at the side of the home were noted as being too shallow and can allow for water to flow out towards the foundation of the home during heavy rain fall or snow accumulation. It is recommended that the swales be cut deeper to prevent water accumulation next to the foundation walls and allow for sufficient drainage.

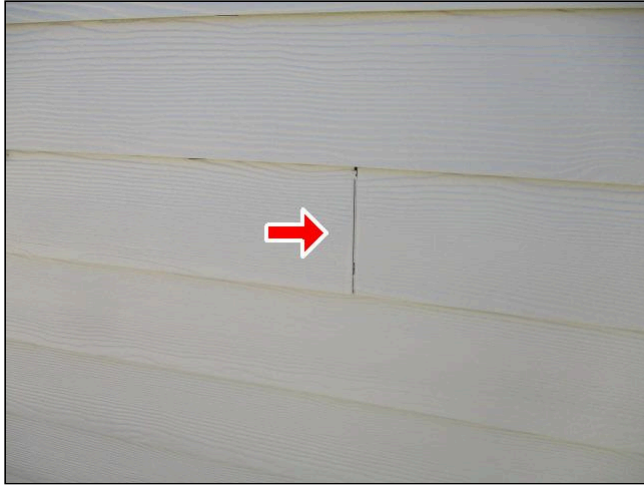
4.0 Item 3(Picture)

All joints between siding should be properly sealed. It is recommended to use elastomeric sealant.

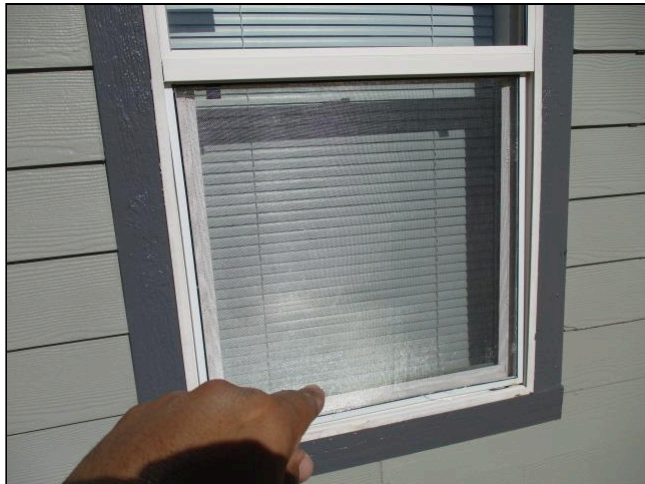
4.2 Item 3(Picture)
(3)

One or more of the window screens were observed to be damaged.

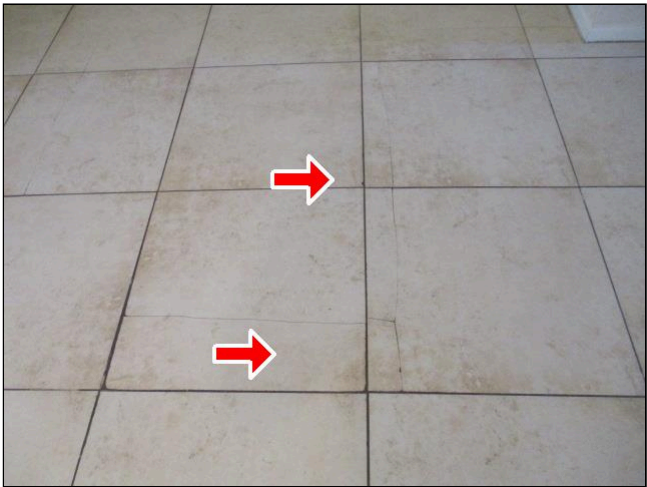
6.1 Item 2(Picture)

The living room had severe floor tile damage visible at the time of the inspection. You should consult with a qualified contractor to discuss options and costs for repair.

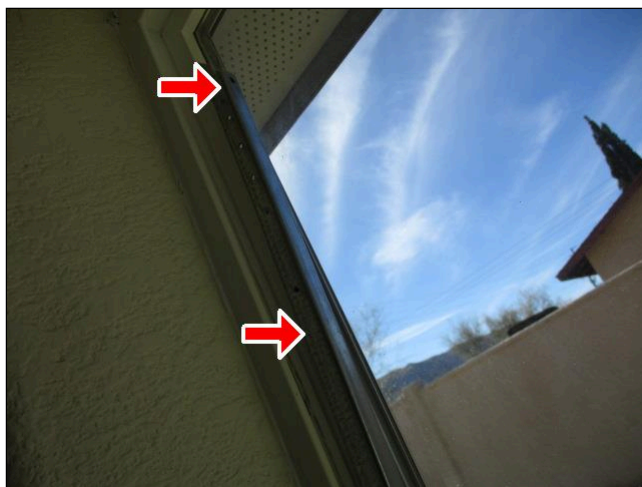
6.8 Item 2(Picture)

Few window in the interior are difficult to operate some are missing the window channel balance. Repair or replacement is recommended.

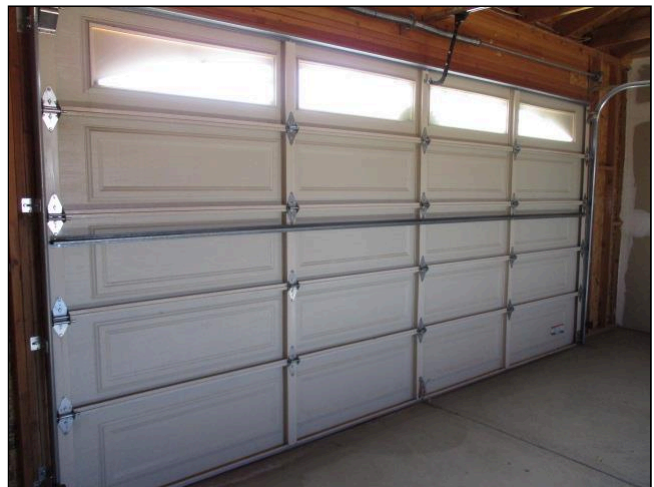
8.0 Item 2(Picture)

A garage vehicle door failed to reverse when a reasonable amount of resistance was applied. The Inspector recommends service by a qualified garage door contractor.

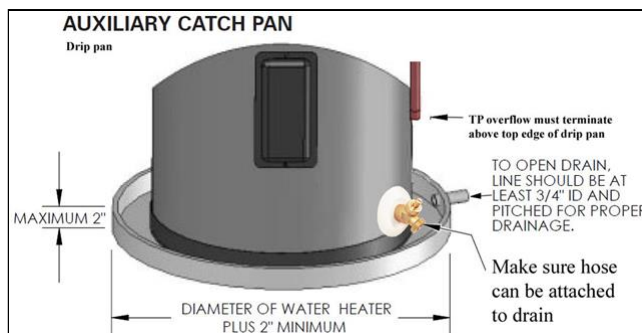
9.0 Item 2(Picture)

Drip pans are recommended below all hot water heaters, This will help contain leaks and prevent water damage.

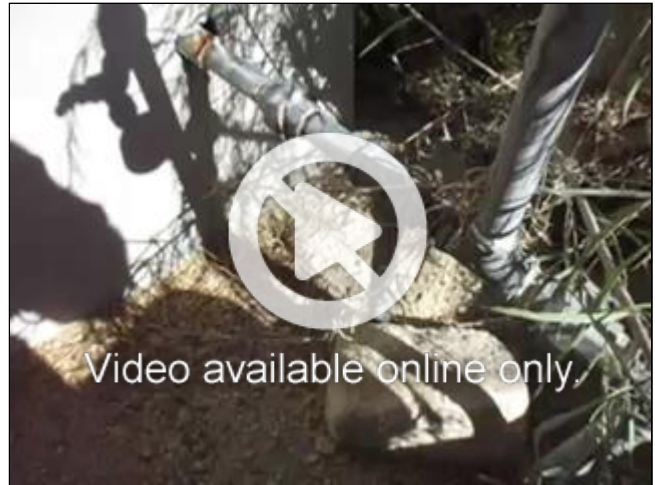
9.4 Item 2(Video)

Corroded supply pipes . The Inspector recommends replacement by a qualified contractor to prevent future damage.

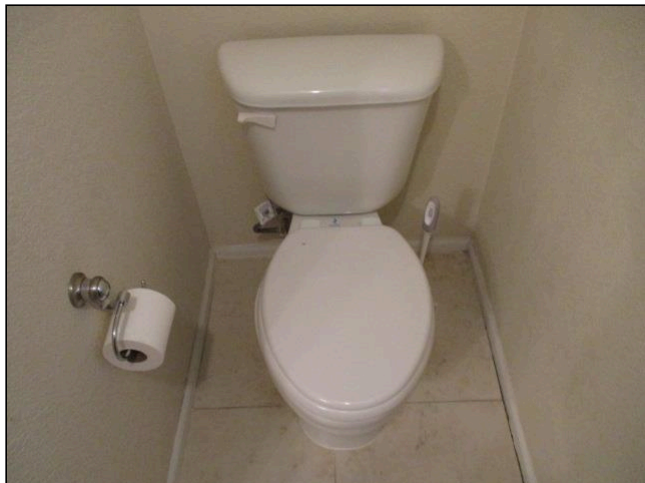
12.2 Item 3(Picture)

The master bathroom, the toilet handle did not return to position, indicating that components in the tank need adjustment or replacement.
